TSB No.	KT2006120701	TSB Type	General
Language	English	Published	12/7/2006
Model	Sorento [BL](2005) Sorento [BL](2006)	Area	N. America
Gr./Sys./Comp	Automatic Transaxle / Automatic Transaxle Control System / TCM		
Symptom	<a href="#">EN5000</a> - poor engine power/acceleration <a href="#">TR1000</a> - engine stalling <a href="#">TR5000</a> - shift delay <a href="#">TR6000</a> - shift shock <a href="#">TR7000</a> - abnormal shift <a href="#">TR8000</a> - slip when shifting <a href="#">TRN001</a> - Noise <a href="#">TRN003</a> - Others		
Subject	<b>Sorento Transmission Shift Hesitation (Trans/Drive - 017) (Updated 2007-01-17)</b>		
Description	<p>This service bulletin provides information related to replacing the vehicle speed sensor wire with a shielded cable. The shielded cable to be replaced is routed from the vehicle speed sensor to the TCM. Some 2005~2006 MY Sorento equipped with a 5 speed automatic transmission (A5SR1) may exhibit a vehicle hesitation and shift shock resulting from an engine rpm drop during the 1-2 and / or 2-3 upshift at approximately 4000 rpm. When this event occurs the TCM engages Engine Torque Reduction (ETR) Mode due to abnormal electrical noise created fr

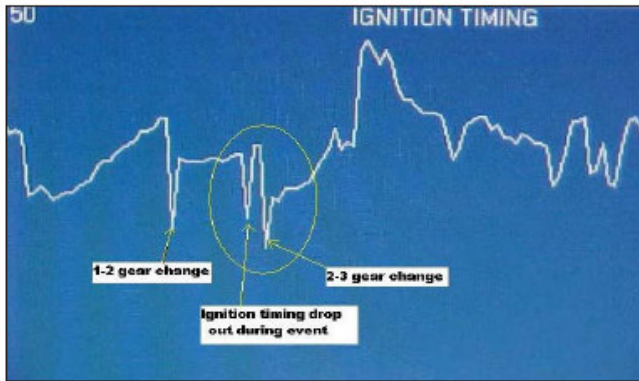
</div> <div style="border: 1px solid black; padding: 5px; margin: 10px 0; text-align: center;"> <p>Screen Shows Example of Unwanted Torque Reduction Mode on the 2-3 Gear Change.</p> </div>
