SERVICE MGR.	X			
RECEPTION	X			
WORKSHOP	X			
PARTS	X	SUBJECT		04/10/95
		<b>Vehicle Battery Discharge (Diesel Only)</b>		NRR/86/14/95/EN
MODEL		AFFECTED VEHICLES

New Range Rover B.M.W Diesel Derivatives		LP Upto 323415		
		LH		
		LJ		
		LD

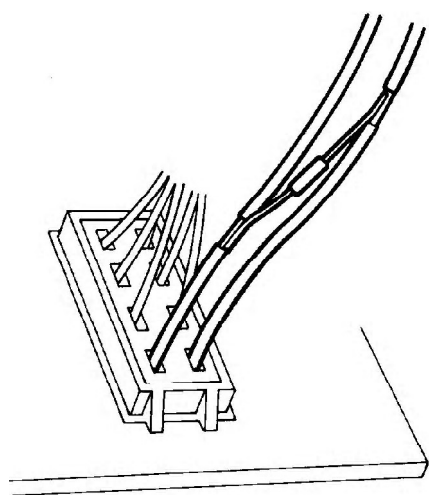
<p>ILLUSTRATION</p>

<p>DETAIL</p> <p>Reports have been received which indicate a rapid discharge of the vehicle battery on New Range Rover Diesel derivatives, over a 2 to 3 day period.</p> <p>Investigations have shown the cause to be the BeCM failing to enter sleep mode (partial shutdown).</p>
<p>ACTION REQUIRED</p> <p>Upon customer complaint of the vehicle battery discharging rapidly, without obvious reason, follow the procedure detailed below.</p>

<p>PROCEDURE</p> <ol style="list-style-type: none"> <li>1. Remove front passenger side footwell closing panel and remove the diagnostic plug from the panel.</li> <li>2. Remove the tape from around the diagnostic harness wires.</li> <li>3. Remove approximately 10mm of insulation from the brown wire (N) pin 16 in the diagnostic connector (see illustration opposite).</li> <li>4. <b>NOTE: Do not cut through the copper wire.</b></li> <li>5. Remove approximately 10mm of insulation from the pink/red wire(KR) pin 7, stagger the gaps in the insulation as per the illustration.</li> </ol> <p>Continued.....</p>
--

6. Crimp one end of resistor onto each wire (see illustration).
7. Solder each of the crimps, as crimping alone is not sufficient to guarantee a reliable fix.
8. Tape full length of resistor with insulation tape to ensure that the wire provides the mechanical support for the resistor.
9. Ensure the BeCM goes to sleep after carrying out this modification, this can be achieved by the following procedure.
10. Ensure the drivers door is closed and the interior lights are switched off, switch on the ignition, switch off the ignition.
11. Open the drivers door and leave open, switch off the interior lights.
12. The message 'Ignition key in' should then be displayed on the instrument pack for 2 minutes.
13. After 2 minutes the message should clear, this will indicate the BeCM is asleep.
14. Refit connector and closing panel
