# **REFLECTIONS ON RUSSIAN ACCIDENT ON AUGUST 17<sup>th</sup> 2009**

**6,400-MW SAYANO-  
SHUSHENSKAYA  
HYDROELECTRIC POWER PLANT**

By Eugenio Kolesnikov – Miami October 12 2009; revised on October 20.

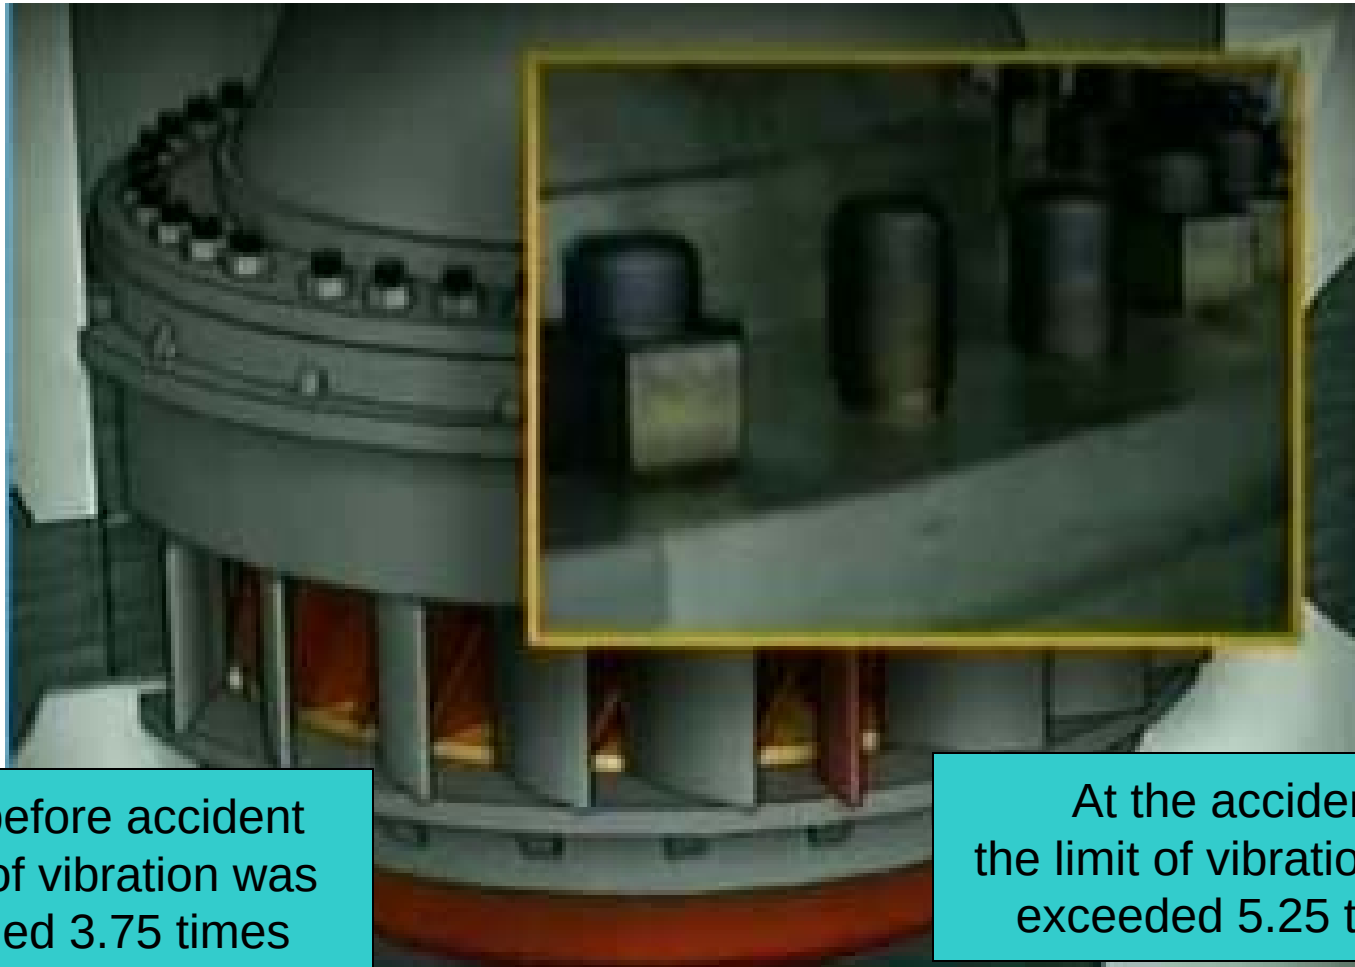
## The Bolts and Vibration at Unit 2

13 min before accident  
the limit of vibration was  
exceeded 3.75 times

At the accident  
the limit of vibration was  
exceeded 5.25 times

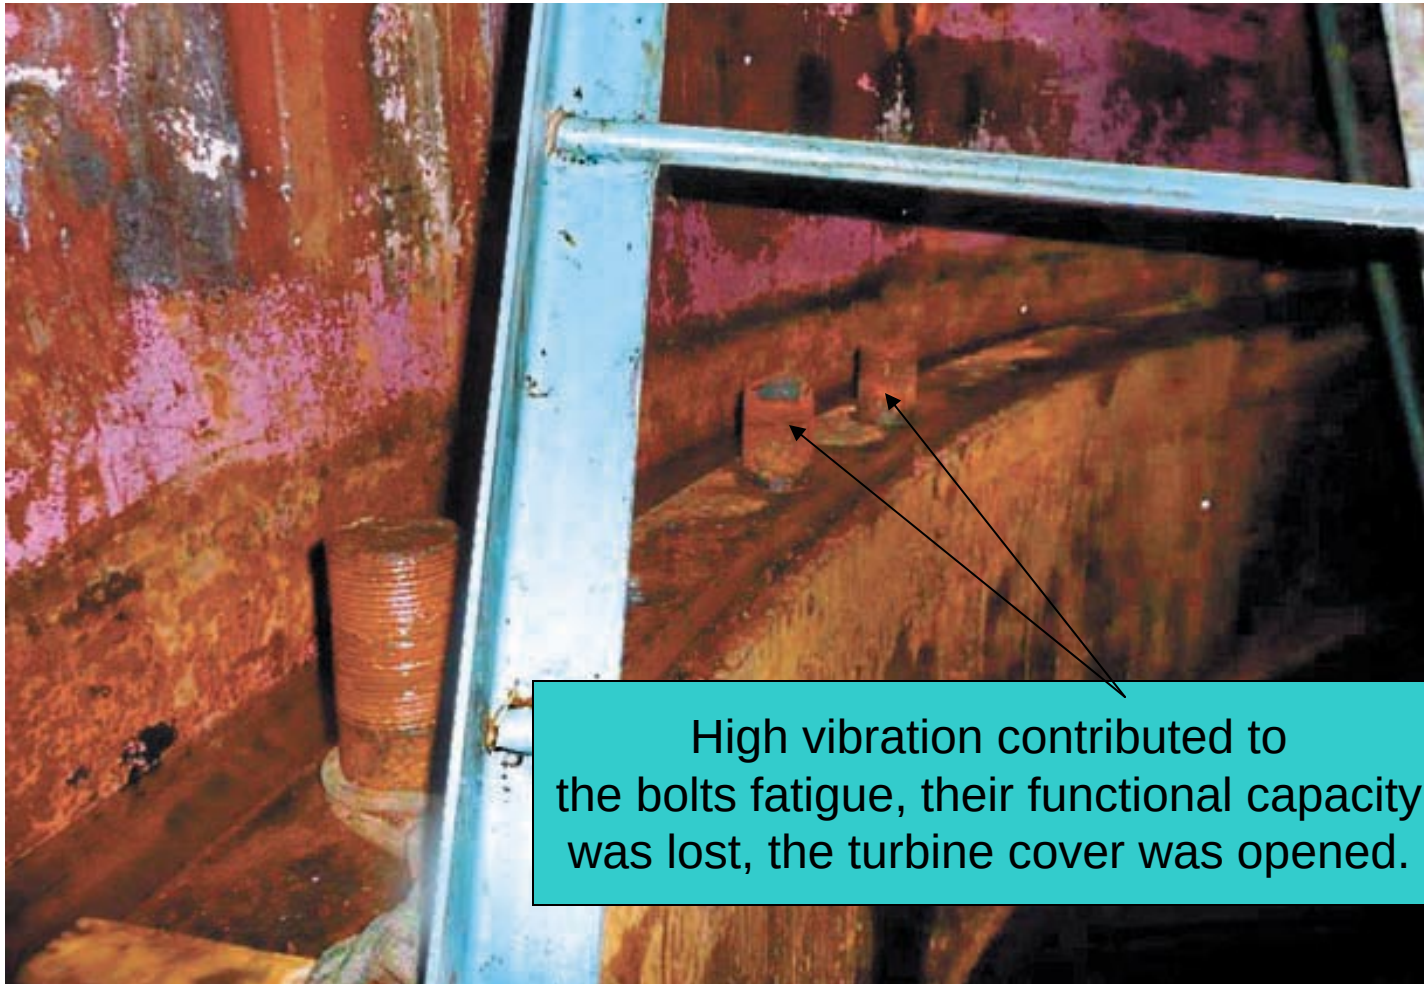
# Turbine Cover Bolts Failed on Unit 2

High vibration contributed to the bolts fatigue, their functional capacity was lost, the turbine cover was opened.

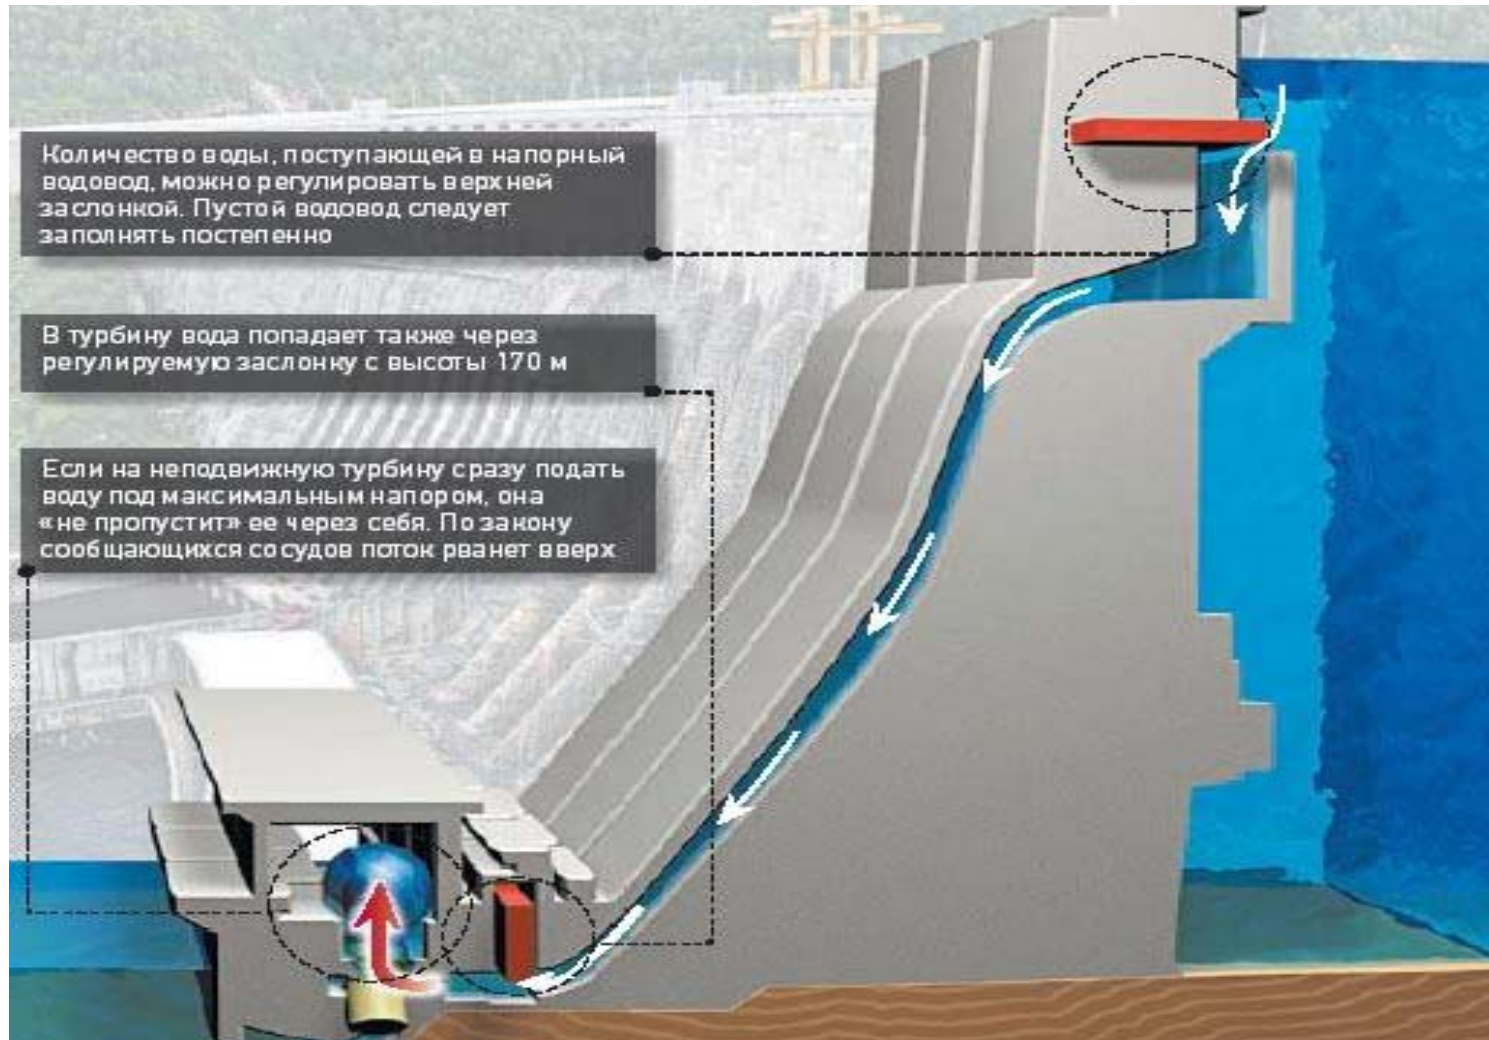
## Unit 2 Was Brutally Lifted

The unit weight is 2,691-t, the rotor weight is 900-t

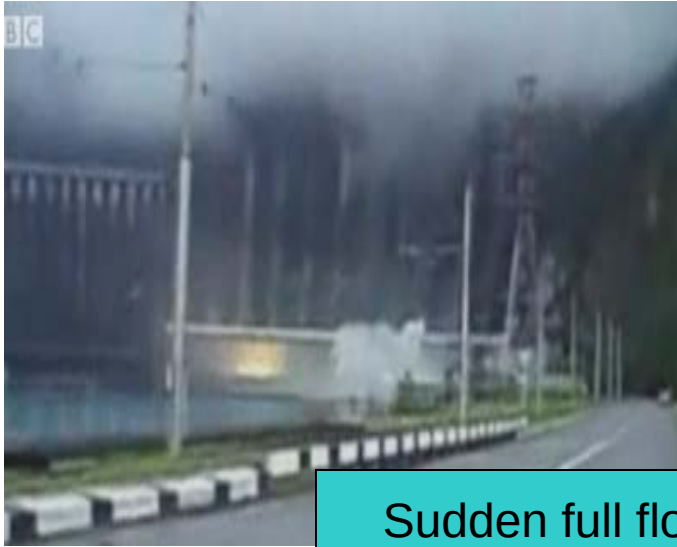
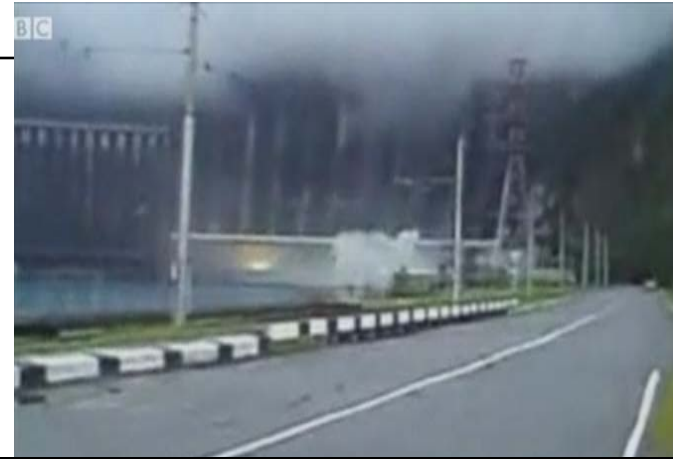
# Short Circuits Caused by Water

Sudden full flooding of the powerhouse disabled controls and protections of the units;  
The control systems stopped operating (no normal and emergency electricity supply)

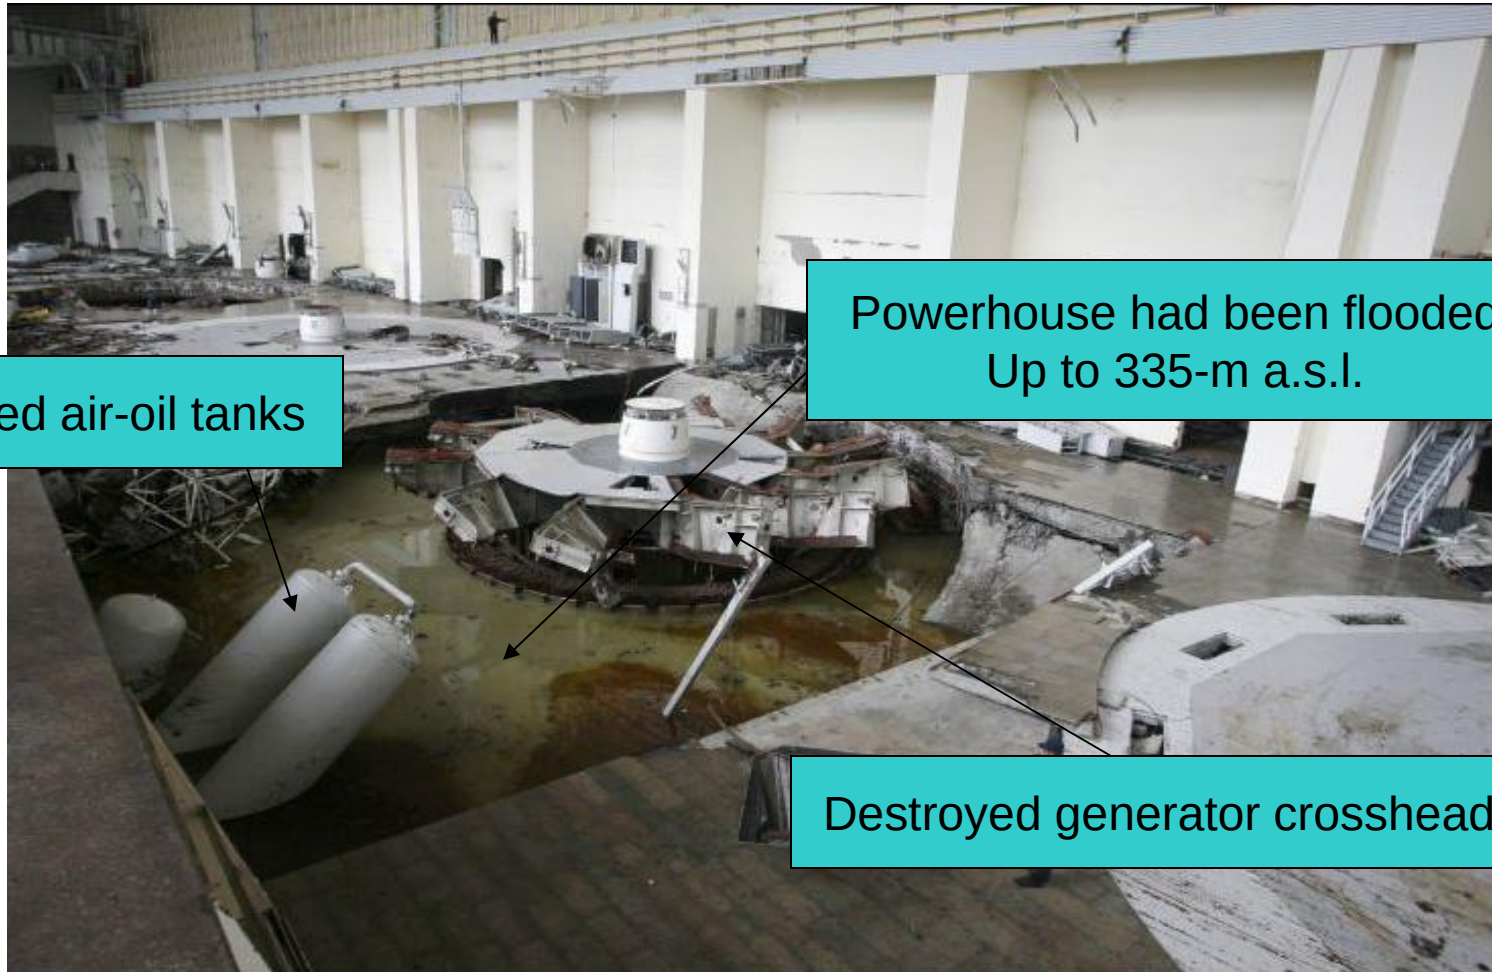
# Generators 7 And 9 Destroyed By Short Circuits

Displaced air-oil tanks

Powerhouse had been flooded  
Up to 335-m a.s.l.

Destroyed generator crosshead

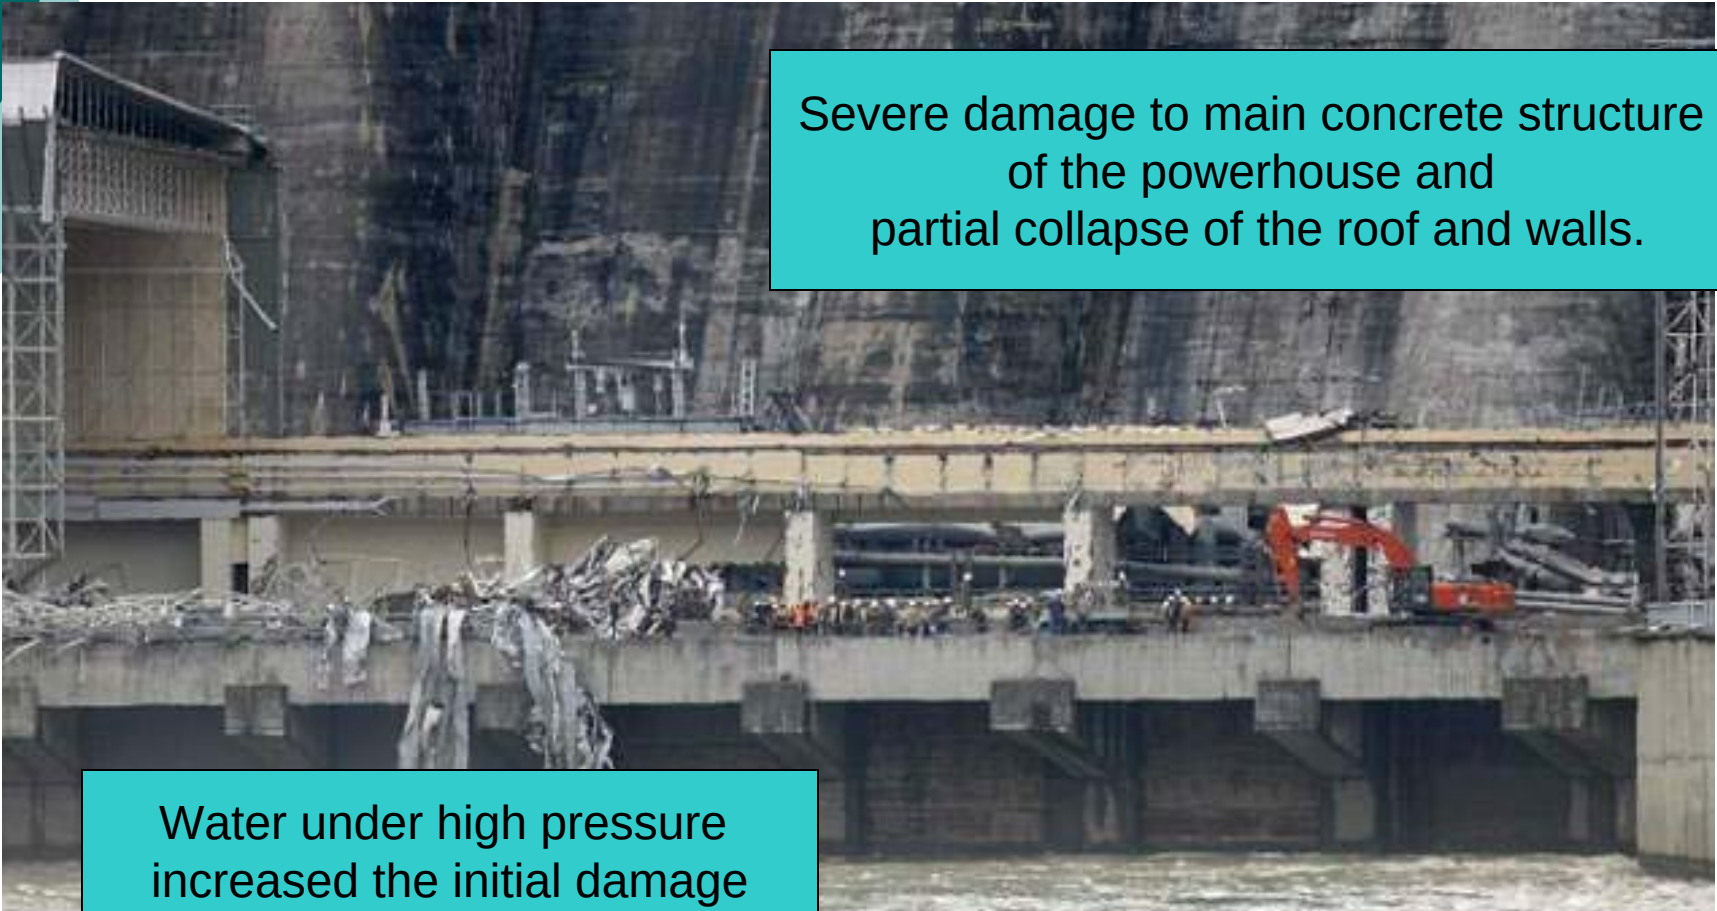
# Major Losses

Severe damage to main concrete structure of the powerhouse and partial collapse of the roof and walls.

Water under high pressure increased the initial damage

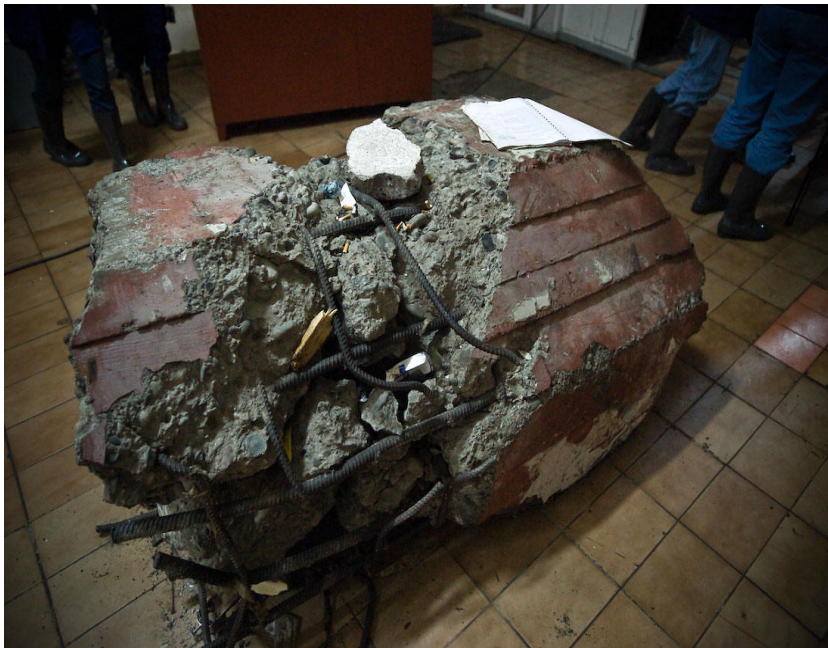
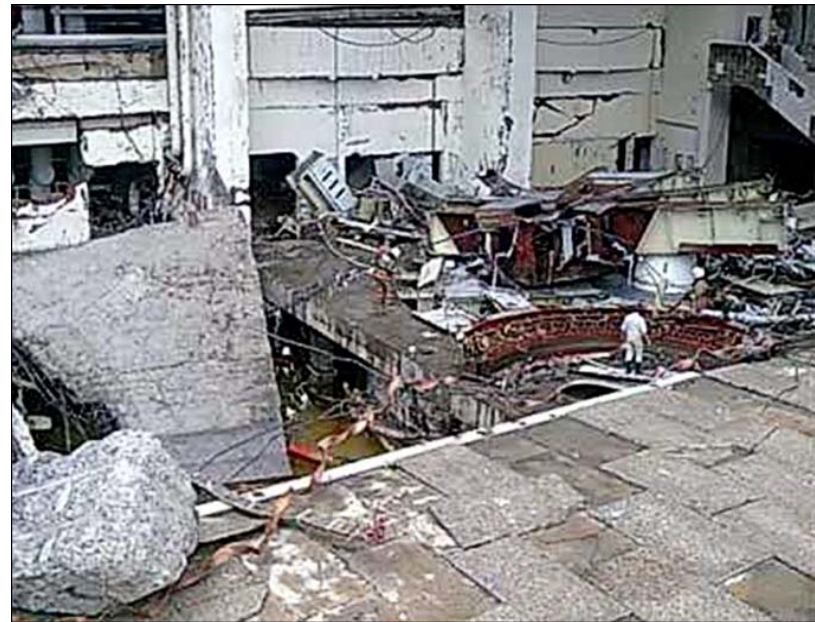
## Major Losses (cont.)

Concrete elements were destroyed by brutal destruction caused by elevation of unit 2, high pressure jet streams and collapse of the structure

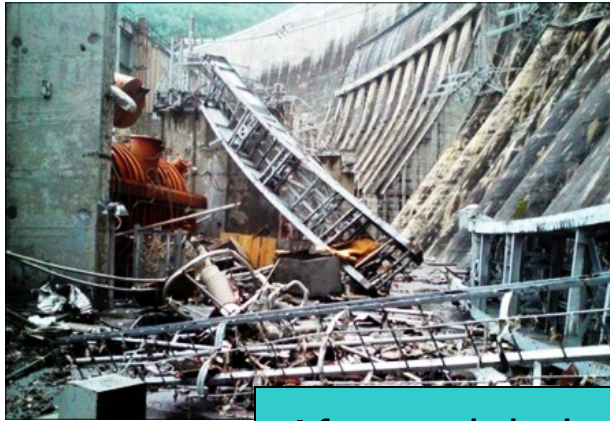
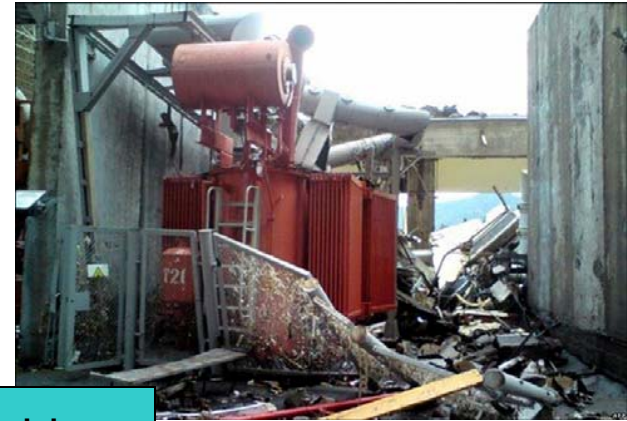
# Damaged Transformers

After and during the accident

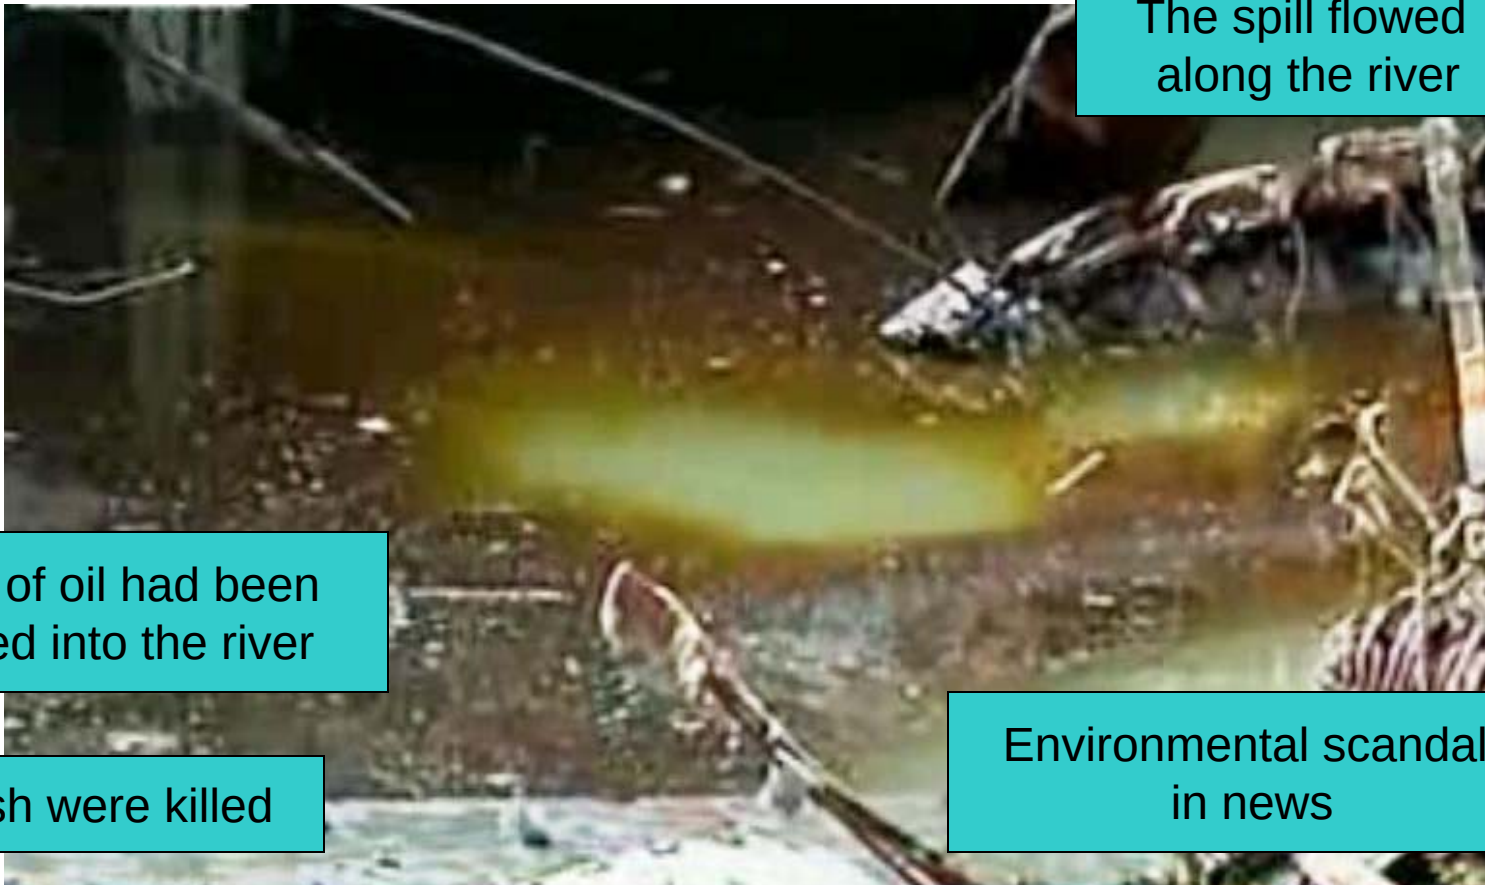
# Environmental Impact

The spill flowed  
along the river

100-t of oil had been  
spilled into the river

Fish were killed

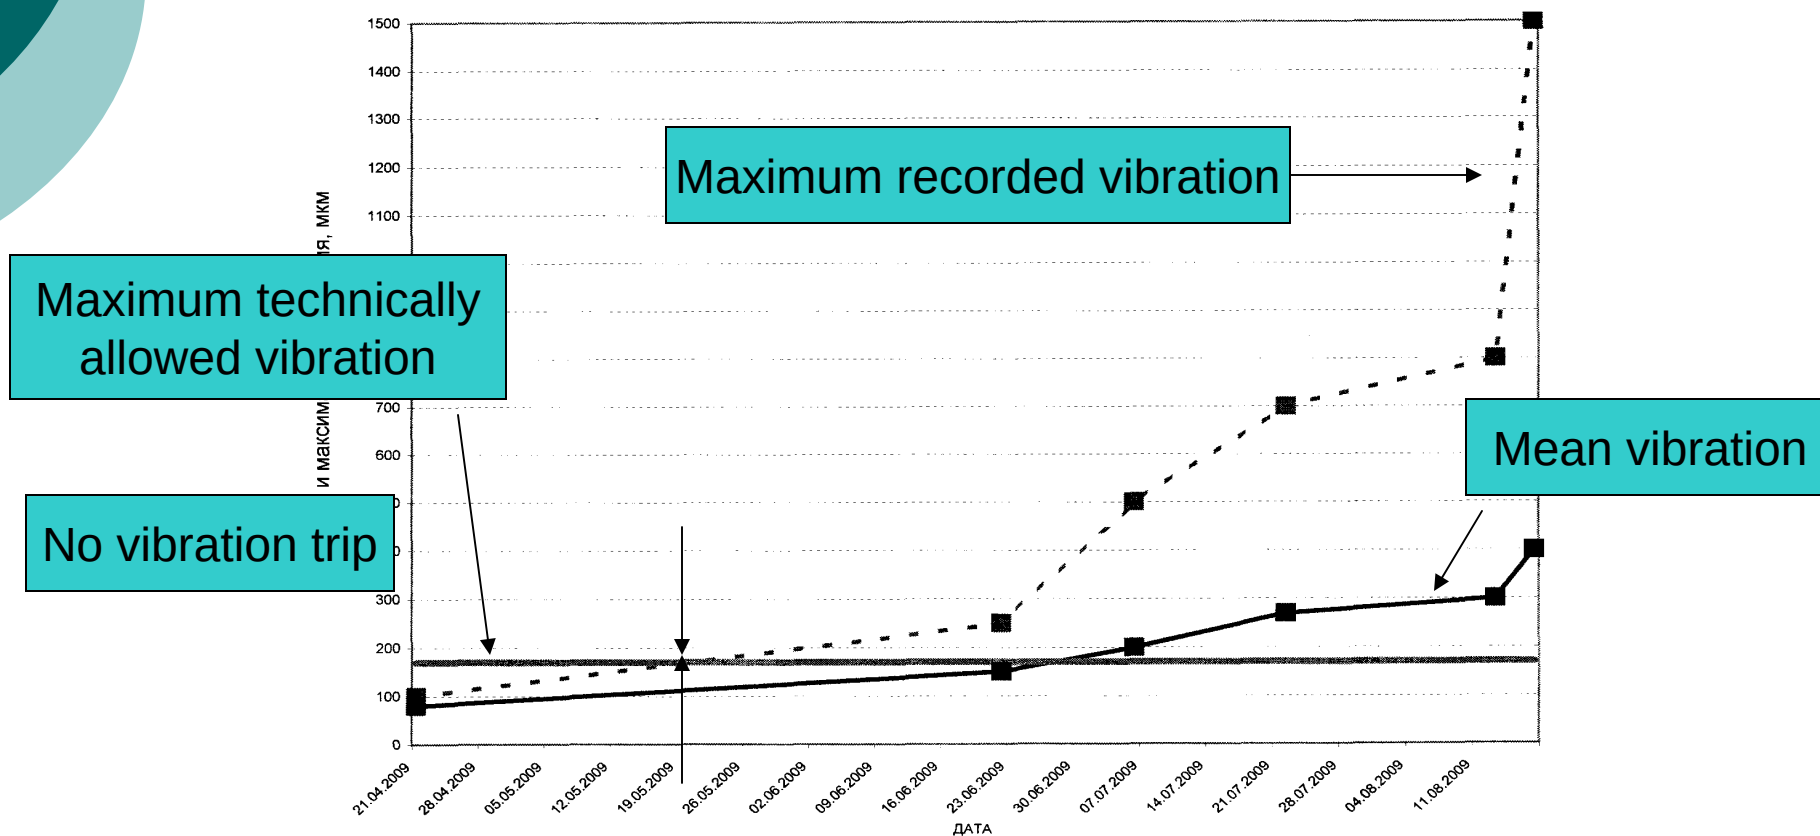
Vibration trend before the accident

# Unit 2 Should Be Shutdown In April Or May 2009

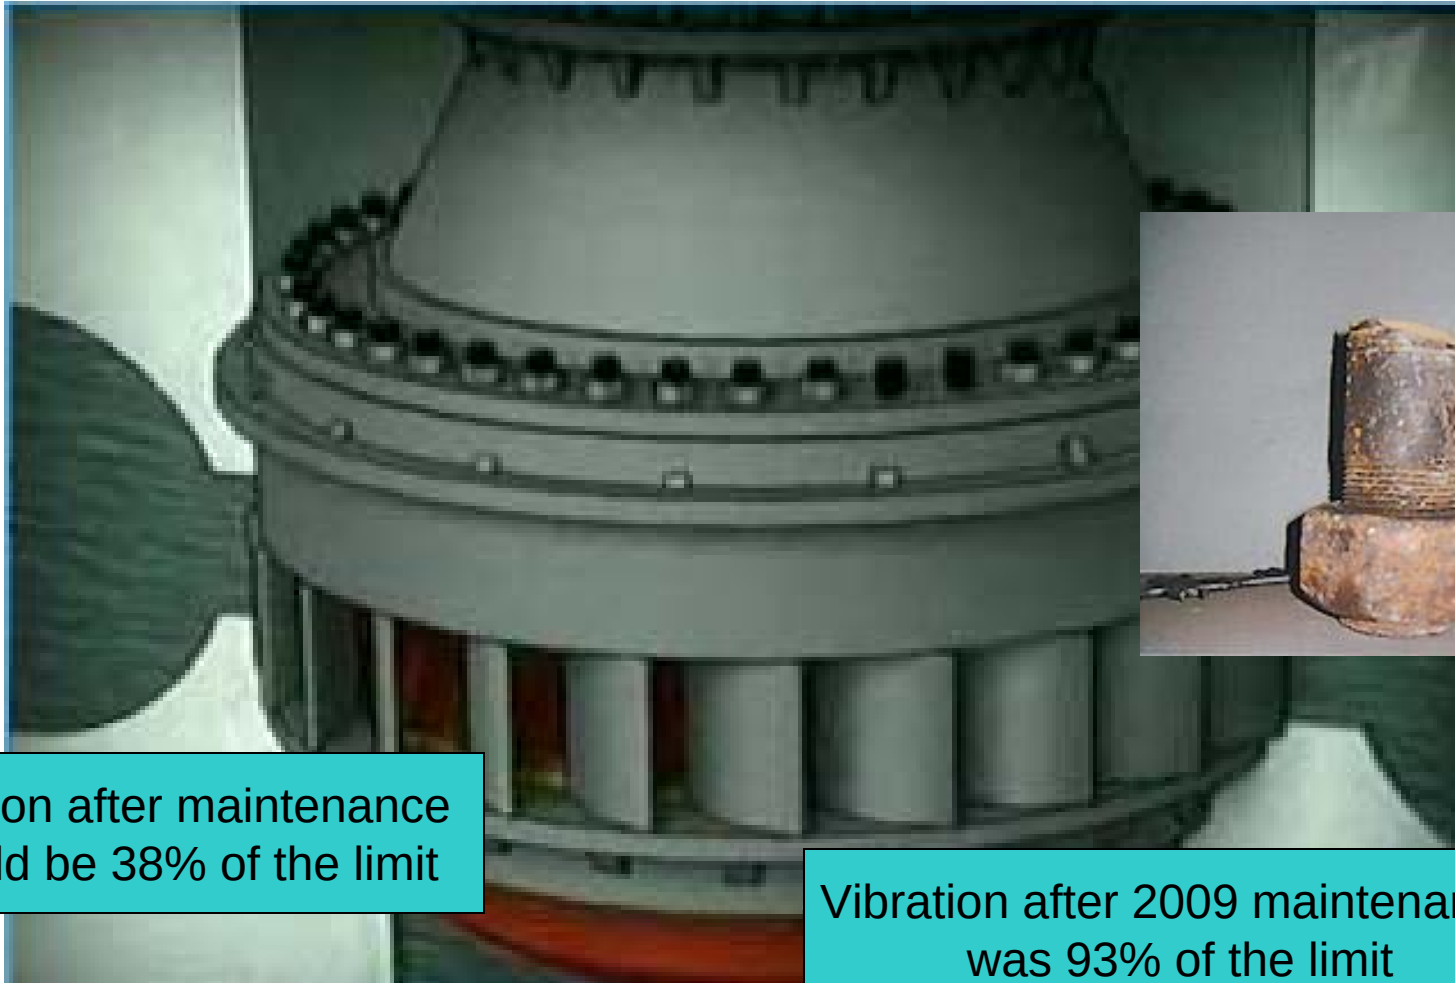
# High Vibration Was From 1982

Vibration after maintenance  
should be 38% of the limit

Vibration after 2009 maintenance  
was 93% of the limit

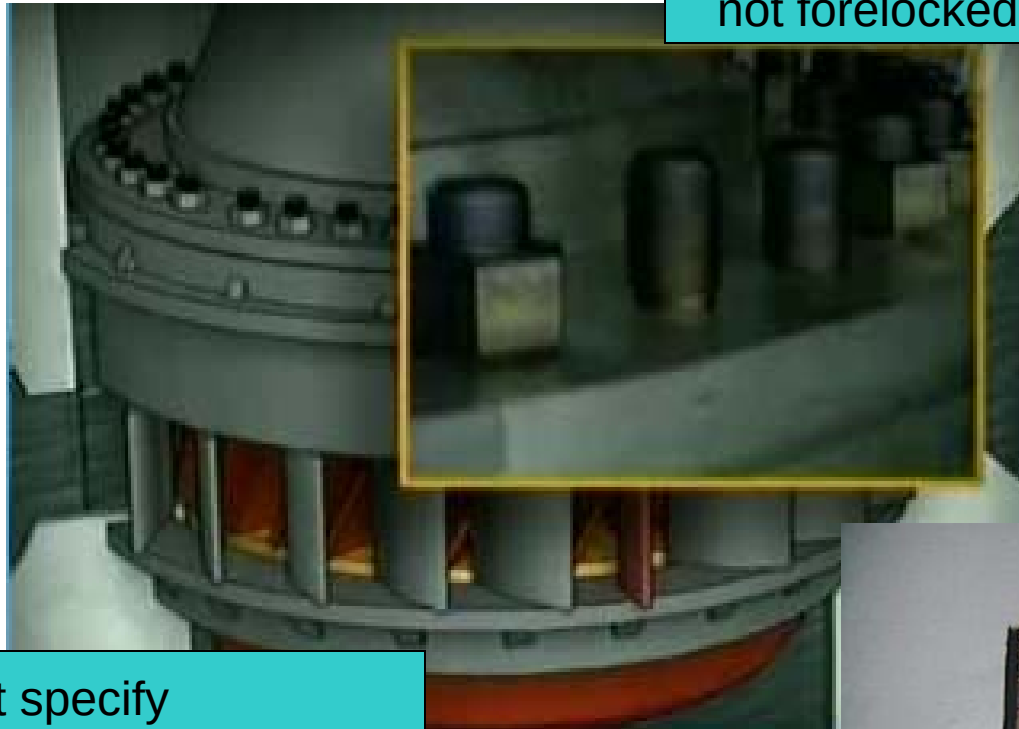
# At Least 6 Nuts Were Not Installed, Total 80 Bolts X 80-mm Diameter

The nuts were  
not forelocked by design

OEM did not specify  
requirements for the bolts maintenance  
and inspections: result-badly worn bolts

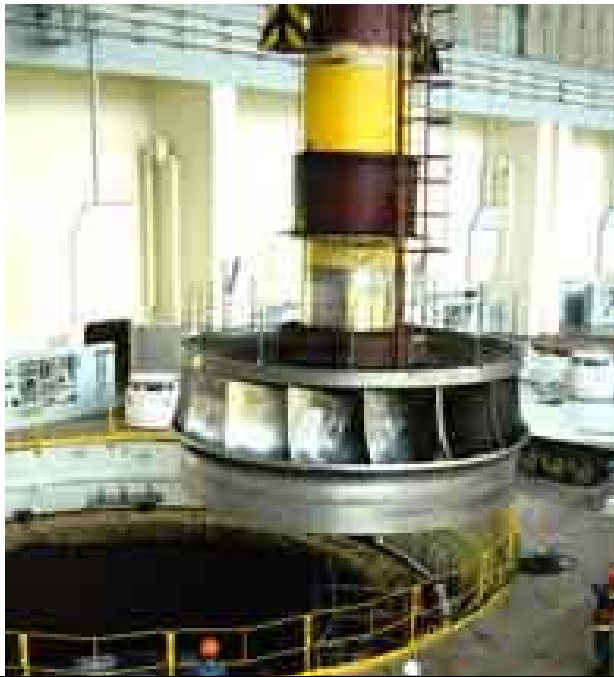
# Issues With Design Of The Units

Cracking of the turbine blades.  
Cracks up to 130-mm

Cavitation loss up to 12-mm

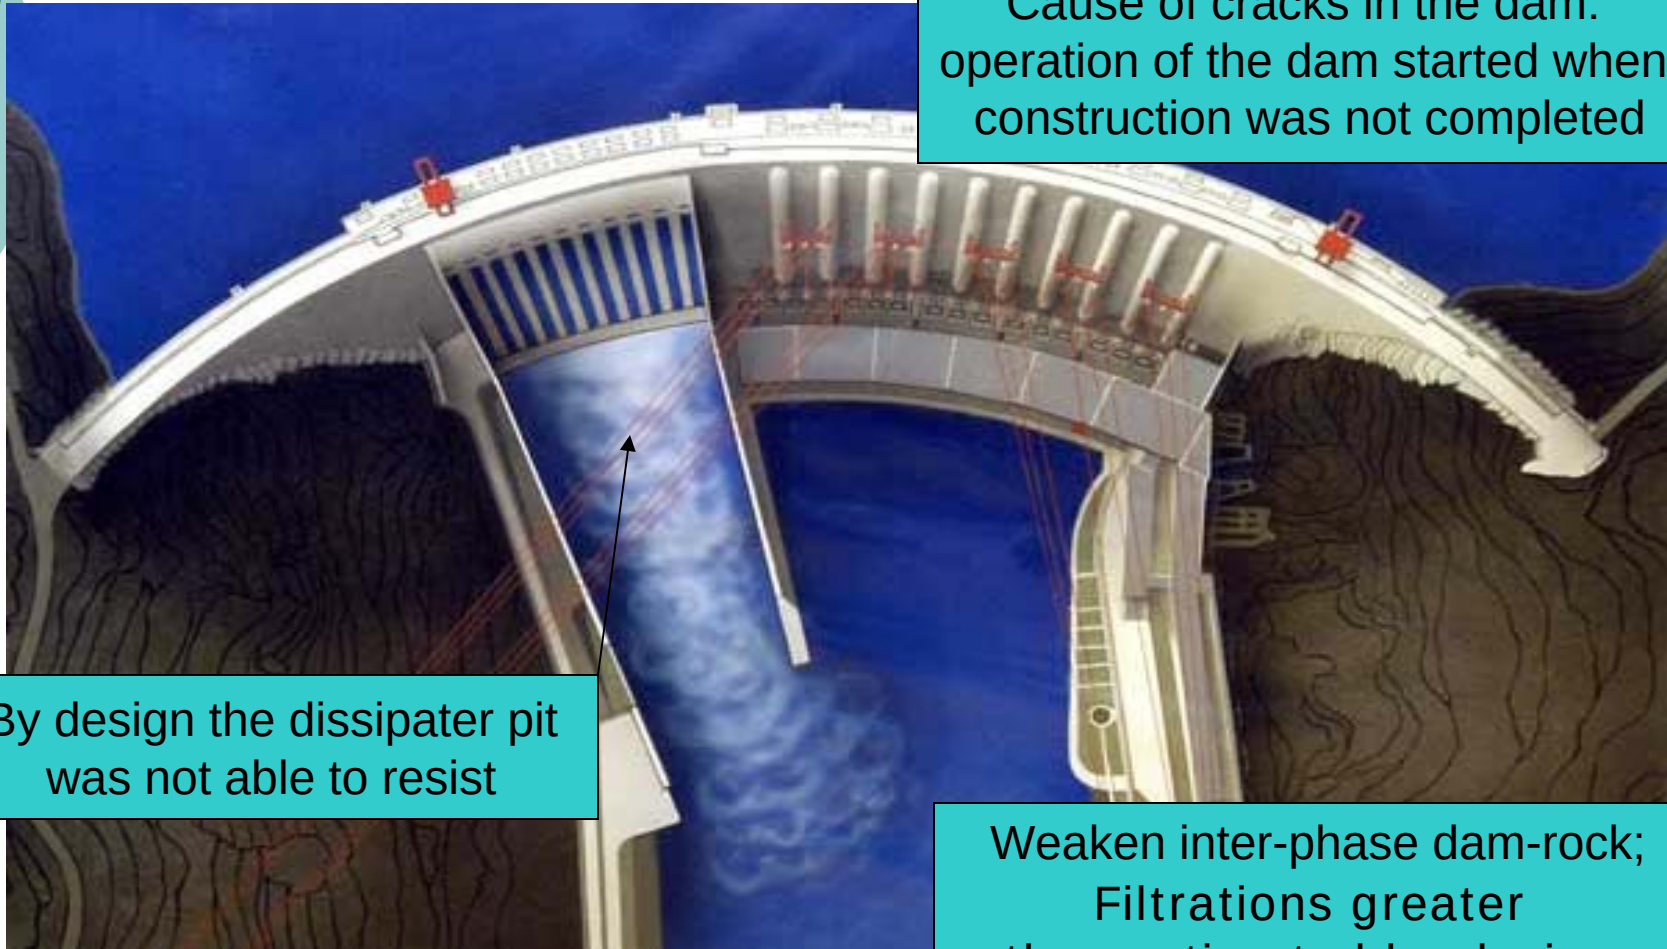
# Major Issues of the Dam

Cause of cracks in the dam:  
operation of the dam started when  
construction was not completed

By design the dissipater pit  
was not able to resist

Weaken inter-phase dam-rock;  
Filtrations greater  
than estimated by design

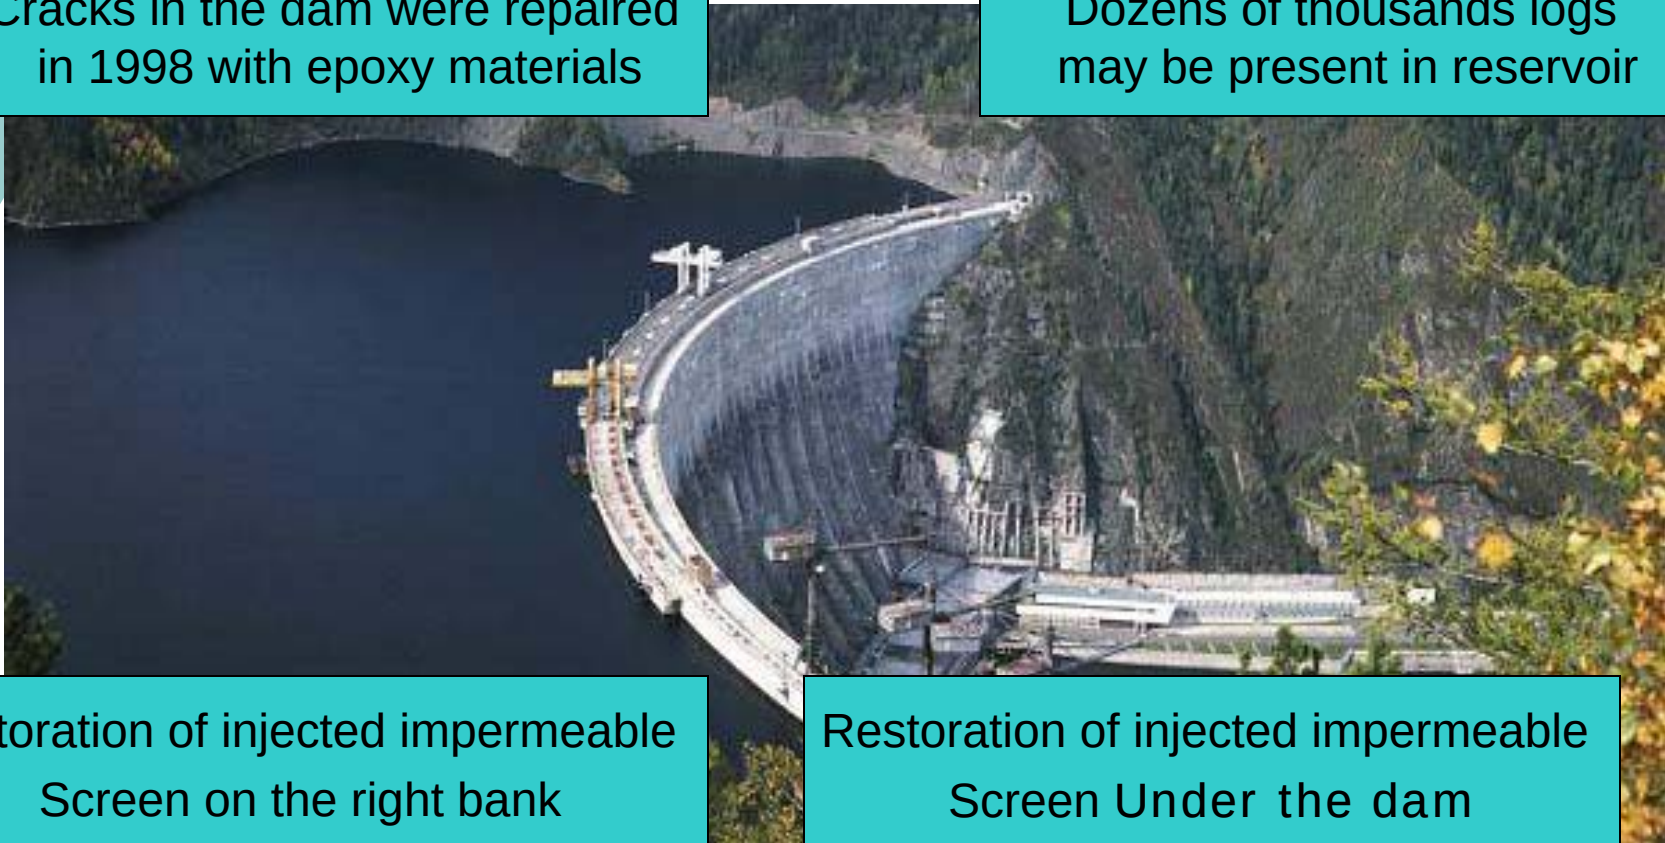
# Dam Was Repaired In 1996 & 1998

Cracks in the dam were repaired in 1998 with epoxy materials

Restoration of injected impermeable Screen on the right bank

Restoration of injected impermeable Screen Under the dam

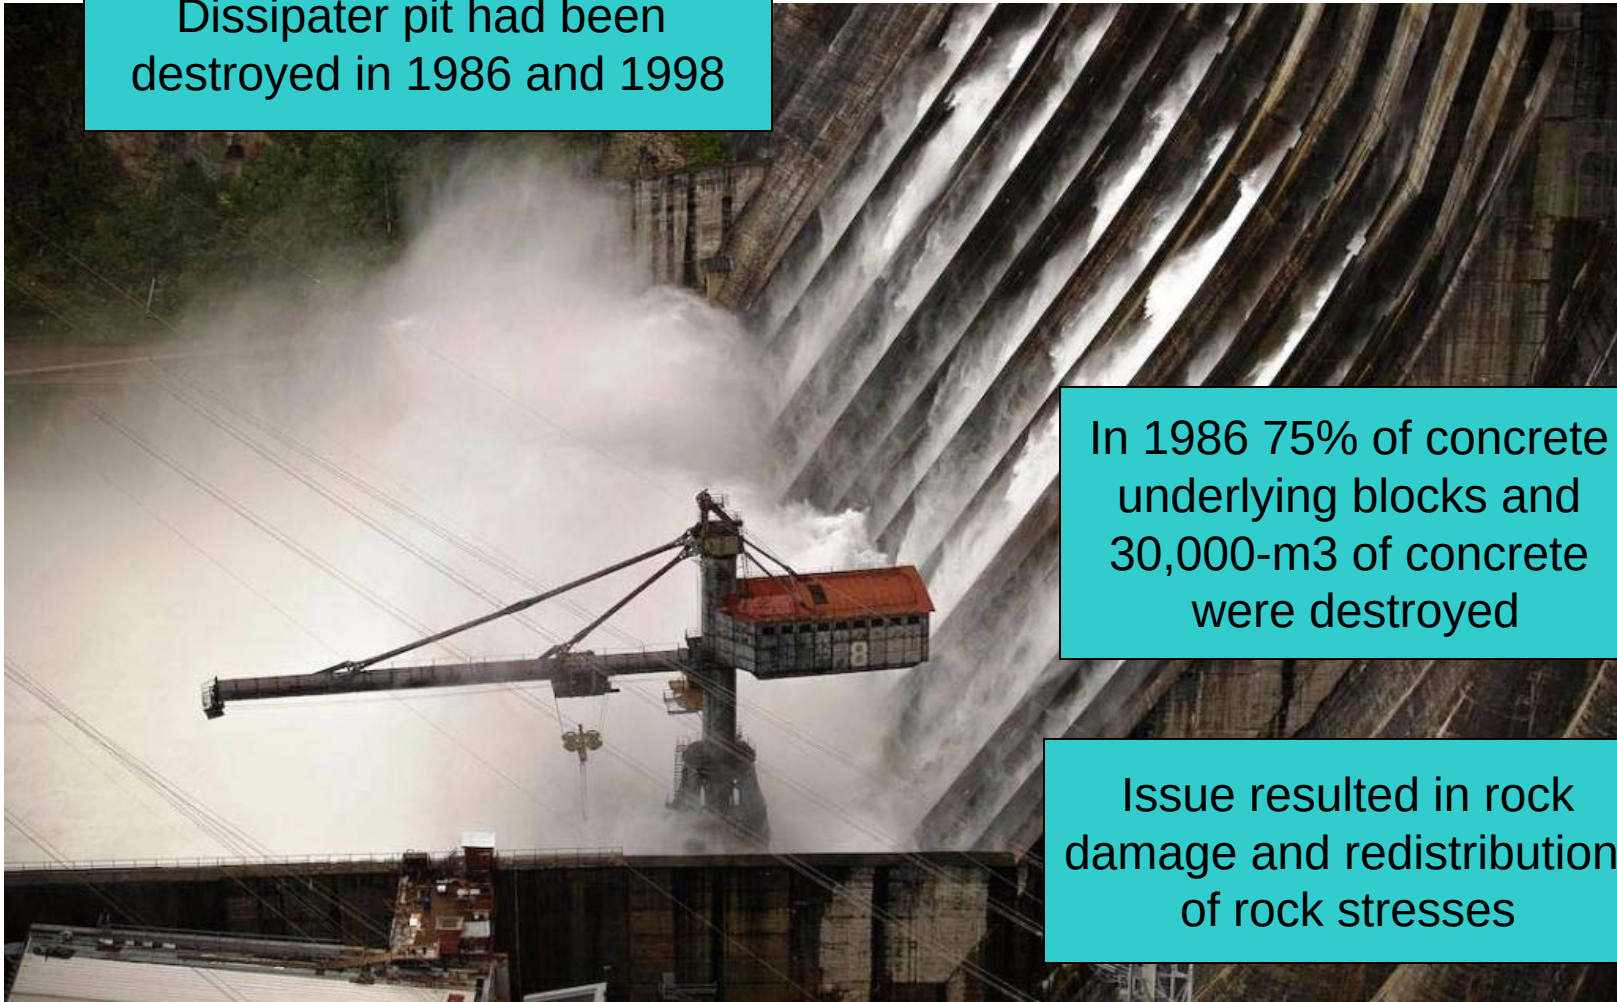
# The Energy Dissipater Requires Repair Now!

Dissipater pit had been destroyed in 1986 and 1998

In 1986 75% of concrete underlying blocks and 30,000-m<sup>3</sup> of concrete were destroyed

Issue resulted in rock damage and redistribution of rock stresses
