**THE PROBLEM SOLVER®**

**OE ball joint fails prematurely**

**MOOG® Problem Solver®  
Lower Ball Joint K3199/K80767**

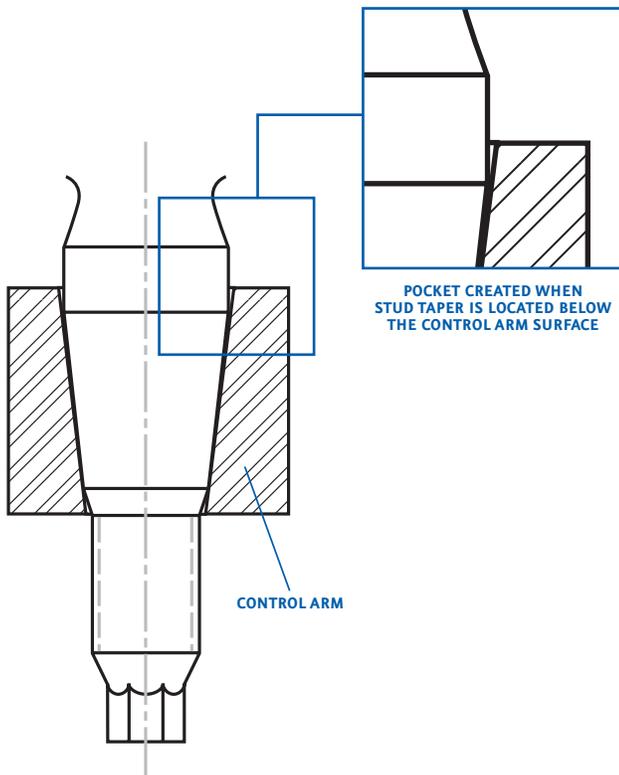
Ball joint boot failures can cause corrosion, accelerated wear and possible joint separation. Failure can be traced to a slight gap between the ball joint stud and control arm. The gap or pocket accumulates moisture, promoting corrosion of the ball joint stud and control arm tapered hole. The corrosion generated by the pocket penetrates under the dust boot, wearing at the sealing surface of the boot. Once exposed to the elements, the sealed, non-serviceable ball joint quickly degrades and fails.
