## Programmed Repairs Engines 602.96, 603.96/97 Combustion

### 07.1 Diesel Injection System

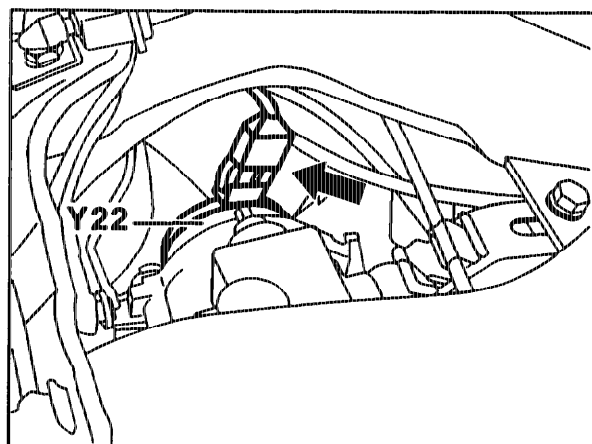
P07-6354-13

Engine surges when idling

Engine 603.96 w/o AJC

Unplug 2-pin connector (arrow) at servomagnet (Y22).

If engine runs properly, check idle speed and set, if necessary, to  $580 \pm 20$  rpm.

Install modified control module part no. 006 545 36 32 and plug in 2-pin connector again.

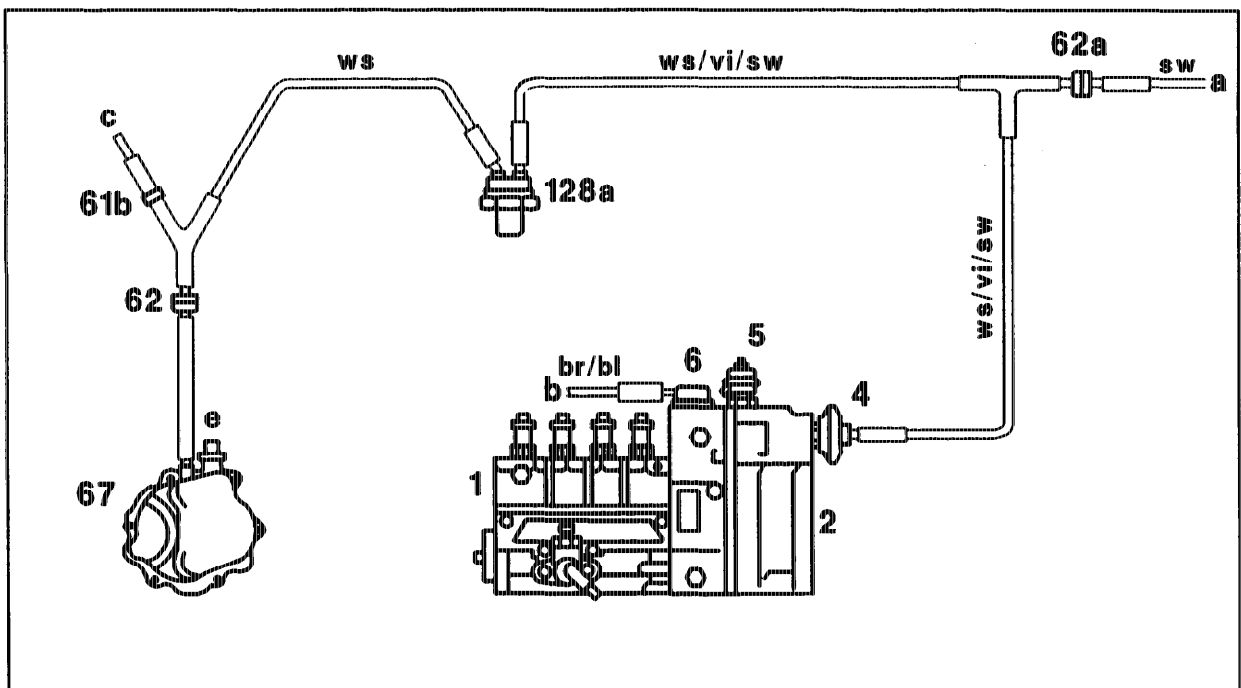
P07-6356-55

Engine cannot be switched off or not easily.

- Vacuum hose and vacuum pump (67) may be split.
- Filter (62) blocked or leaking.
- Restrictor (61b, orange) may be blocked.
- Vacuum of vacuum pump not sufficient. Check vacuum at ancillaries connection. Specification when engine idling after 30 s at least 700 mbar.

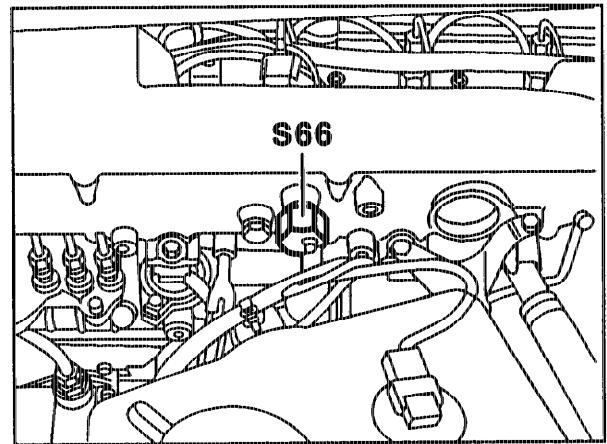
P07-6355-13

Engine misfires at full load from 2000 rpm

Boost pressure too high or engine overload protection activated too soon.

Test boost pressure with connector unplugged from engine overload protection switch (S66).

If boost pressure  $> 0.95$  bar, boost pressure control valve of turbocharger faulty. Replace turbocharger.

If boost pressure  $< 0.95$  bar, switch engine overload protection (S66) reacting too soon. Replace switch (S66).

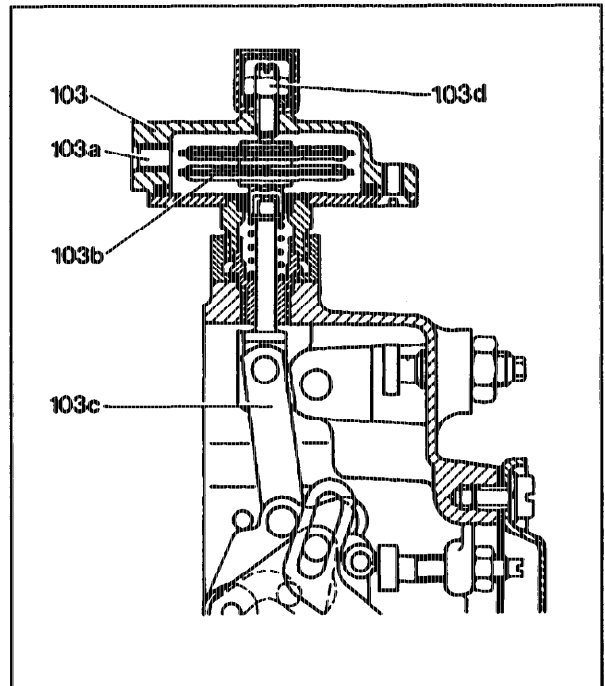
P07.11-0003-02

Sluggish acceleration when engine cold up to about 2000 rpm

- a) Full load stop not correctly set.
- b) Insufficient full load quantity.

- a) Check setting of accelerator control linkage, adjust (see RA30-1010).
- b)
  - 1 Remove boost air pipe, install (see RA14-1310).
  - 2 Set full load quantity at barometric pressure compensation unit:
    - Take off cap (black) on barometric pressure compensation unit (103).
    - Slacken lock nut (103d).
    - Use a screwdriver to turn setting screw about 1/4 turn to the left.
    - Tighten lock nut (103d).
    - Fit on cap.
