G Class Transfer Case

Transfer Case Identification

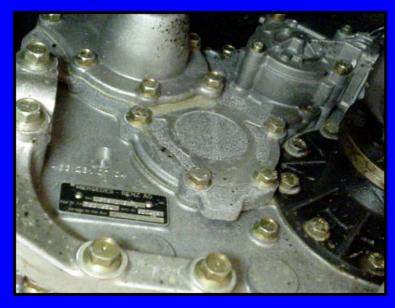
VG 150 E 3W / 2.14

Low Range Ratio

3 Shafts

Electronic Motor

Input Torque (Nm)

ID tag at rear of Transfer case

Only 1 version / ratio for USA application - High range 1.05

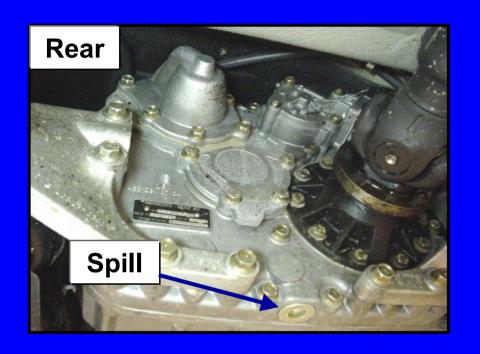
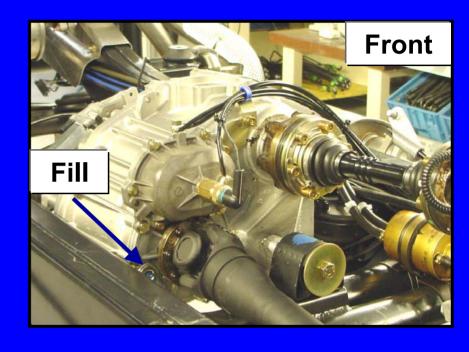
Maintenance

- Every B service check oil level (check cold)
- Oil change 60,000 miles or 5 years since last change
- Oil grade DEAGEAR Synthetic SAE 75W 90
 (sheet # 231.1 car / off road vehicles)
 2.8 liters or 2.9 quarts

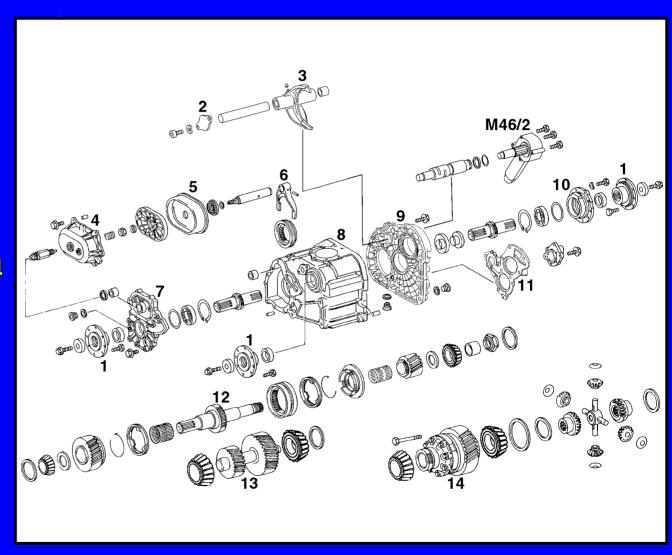
Exploded View

- 1. Coupling flange
- 2. End cover
- 3. Shift fork
- 4. Shift cylinder housing
- 5. Diaphragm
- 6. Differential lock shift mechanism
- 7. Front transmission cover
- 8. Transmission housing
- 9. Intermediate flange
- 10. Rear axle input shaft cover
- 11. <u>Intermediate flange</u> cover
- 12. Input shaft
- 13. Countershaft
- 14. Differential

(M46/2) Transfer case actuator motor

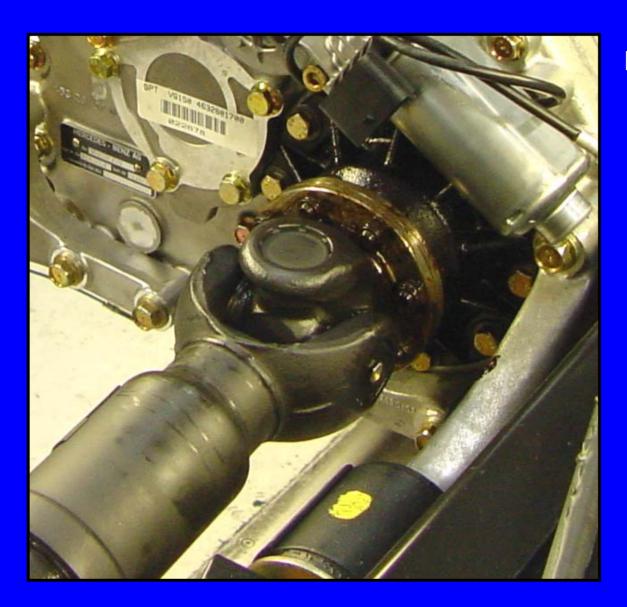
Coupling Flanges

Flange position is vital:

- mark propeller shaft to flange
- mark flange to shaft

Tool for removing coupling flanges

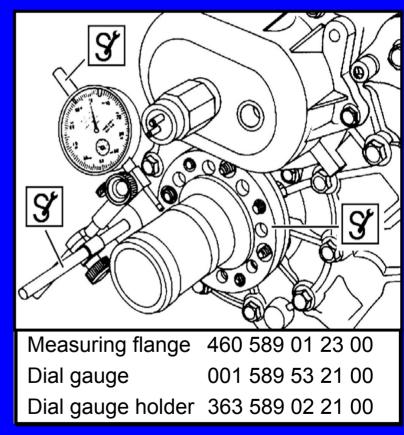
Coupling Flanges

Check concentricity of flange

- vibration complaint
- replacement of coupling flange

Specification: ≤ 0.07 mm

If there are deviations perform adjustment:

- Offset flange 180° clockwise & recheck
- If not within specification offset flange 90° clockwise & recheck
- If not within specification offset flange 180° clockwise & recheck
- If the specified concentricity value is not achieved, replace flange & recheck

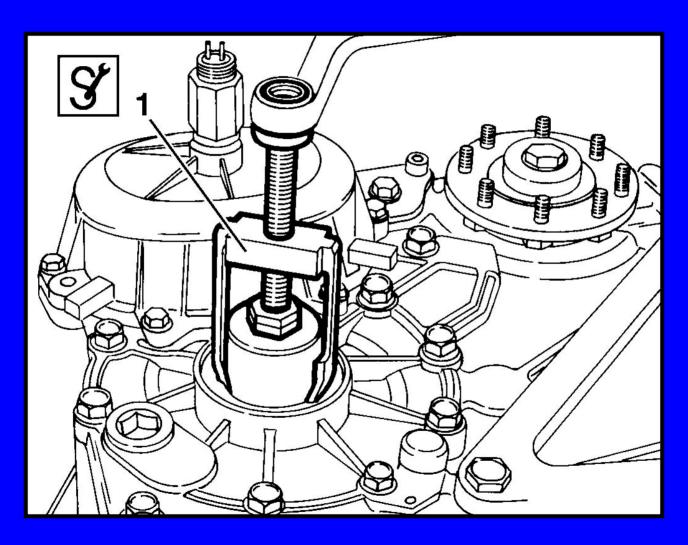
Radial Shaft Seals

Puller part # 463 589 00 33 00 28 B

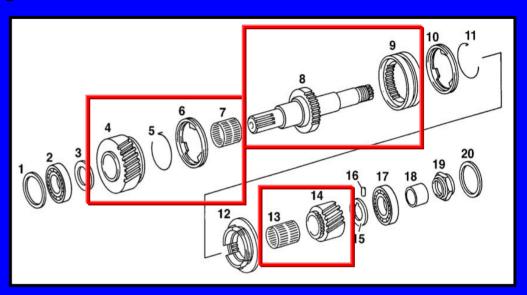
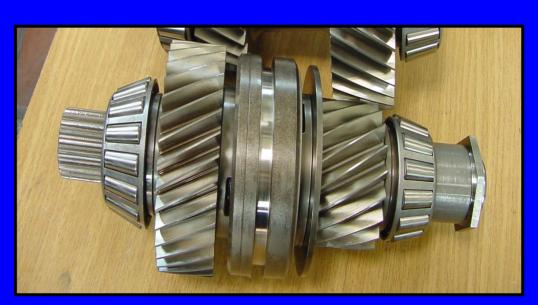
Input Shaft

- 1. Washer
- 2. Tapered roller bearing
- 3. Washer
- 4. High range gear
- 5. Spring
- 6. Synchronizer cone
- 7. Needle roller bearing
- 8. Input shaft
- 9. Sliding sleeve
- 10. Synchronizer cone
- 11. Spring
- 12. Synchronizer ring
- 13. Needle roller bearing
- 14. Low range gear
- 15. Washer
- 16. Straight pin
- 17. Tapered roller bearing
- 18. Spacer nut
- 19. Nut
- 20. Washer

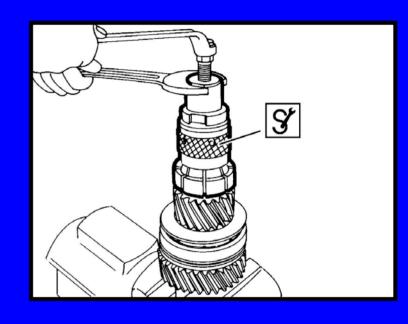
Input Shaft

Input shaft serviceable

- use correct tools as described in WIS to disassemble / assemble shaft
- when installing new bearings heat bearings to 120°C Max.

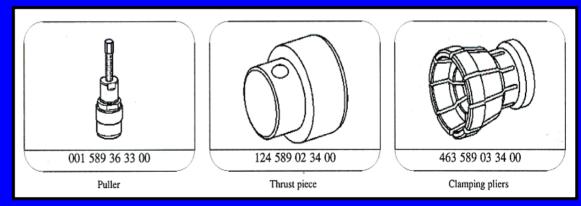
If parts are replaced adjust input shaft axial play

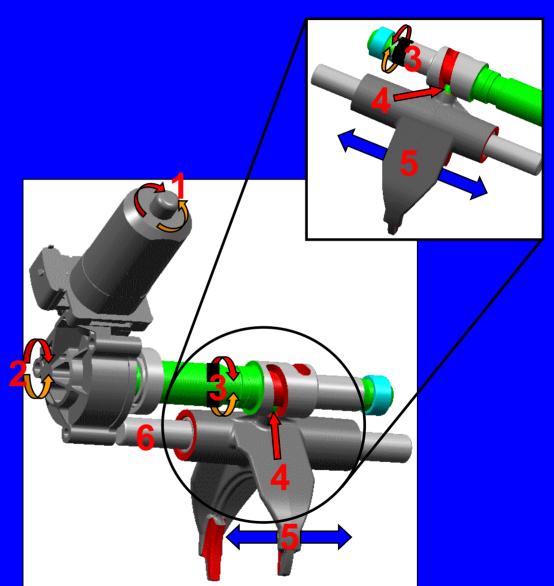
High / Low Shift Fork

- 1) Motor (M46/2)
- 2) Worm gear
- 3) Actuating wheel
- 4) Barrel sleeve
- 5) Shift fork
- 6) Shifter shaft

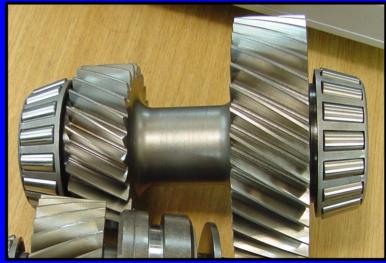
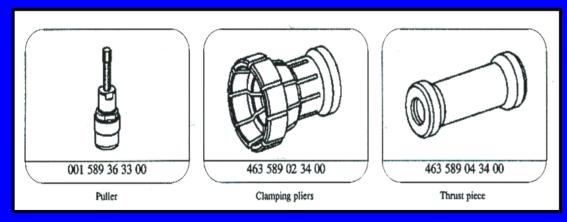
- Countershaft gears not serviceable
 - if damaged, replace assembly
- Countershaft bearings serviceable
 - use correct tools as described in WIS to disassemble / assemble shaft
 - when installing new bearings heat bearings to 120°C Max.

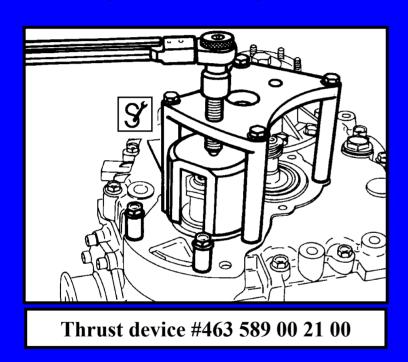
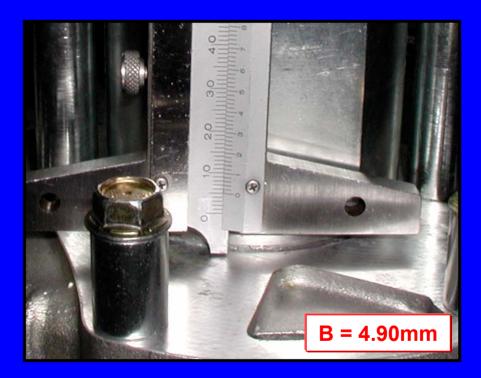
Axial Play Adjustment

Procedure is the same for the input and countershaft. The following example shows input shaft axial play adjustment.

- 1) Install thrust device with spacers & tighten compressing bolt to 15Nm
- 2) Spin input shaft approx. 10 times to position the bearings
- 3) Measure distance between outer race and intermediate flange

- B (example 4.90mm)

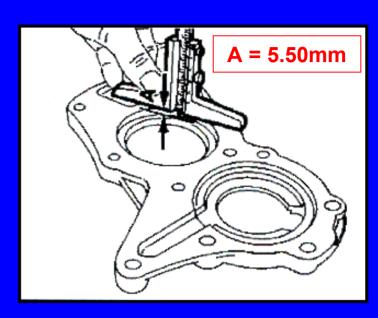
Axial Play Adjustment

4) Measure depth between intermediate flange cover and bearing seat - A

Calculation example:		
Depth	Α	5.50 mm
Distance	В	<u>4.90 mm</u>
Difference		= 0.60 mm
Preload on bearings		+ 0.10 mm
Shims required		= 0.70 mm

Spec is 0 mm play + preload of $(0.1 \text{ mm} \pm 0.05)$

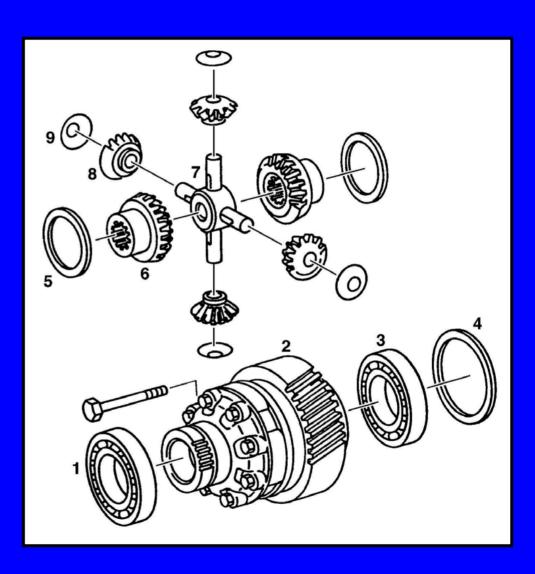
Center Differential

- 1. Front tapered roller bearing (shown with inner & outer race)
- 2. Differential housing
- 3. Rear tapered roller bearing (shown with inner & outer race)
- 4. Shim
- 5. Thrust washer
- 6. Shaft bevel gears
- 7. Differential spider gears
- 8. Differential bevel gears
- 9. Spherical washers

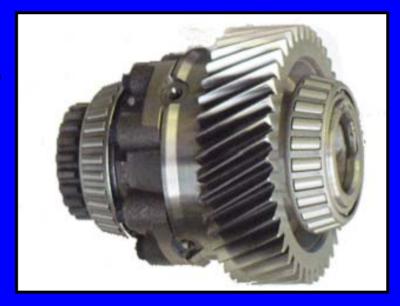
Center Differential

- Center differential serviceable
 - use correct tools as described in WIS to disassemble / assemble
 - when installing new bearings heat bearings to 120°C Max.

- check friction torque of differential AR28.50-P-1023-05B
- If other parts are replaced
 - adjust center differential axial play AR28.50-P-1023-04B

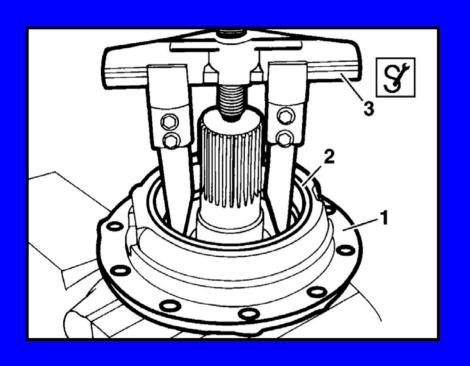
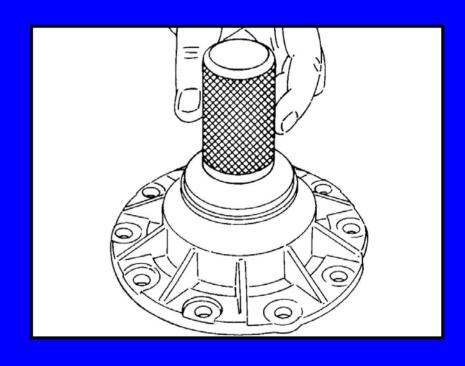
Bearing Cap

Puller 000 589 88 33 00 28 B

- Used with puller arms
- 463 589 05 34 00 (26C)
- Thrust piece 463 589 01 34 00 (28B)

Drift punch 463 589 00 15 00 28 B

Center Differential Axial Play

- Remove outer race (2) and shims (3) from axle input shaft bearing cap (4)
- Install new outer race with a 1.0 mm shim
- Install axle input shaft cover (4) with 3 equally spaced bolts (5 Nm)
- Measure gap at bearing cap with feeler gauge (e.g. 0.80 mm)
- Calculate correct shim required: Specification = 0.1 mm (+/- 0.05 mm)

0.80 mm - 0.10 = 0.70 mm shim (shims available 0.1, 0.15, 0.3 & 1.0 mm)

Remove outer race and reinstall with appropriate shims

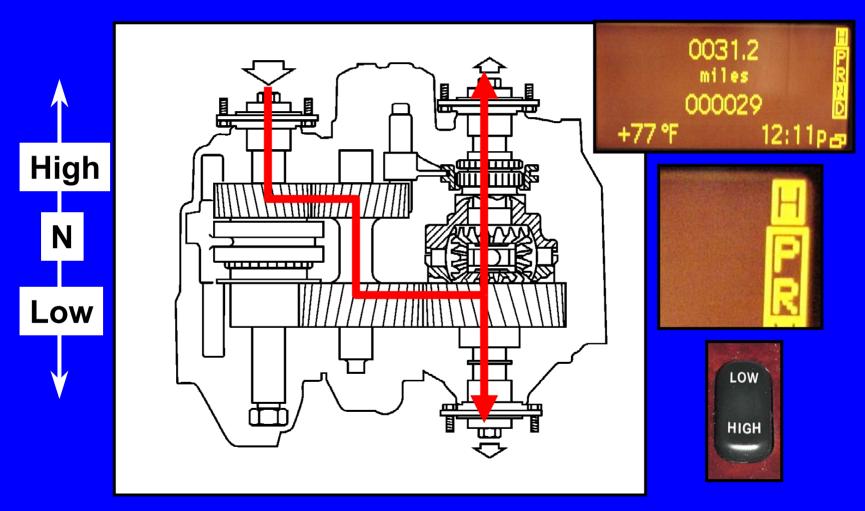
High Range

1.05:1

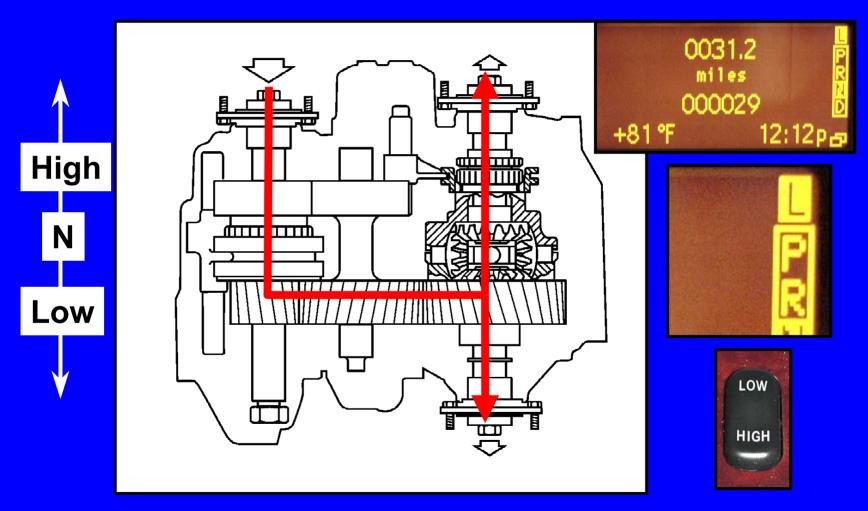
Low Range

2.15:1

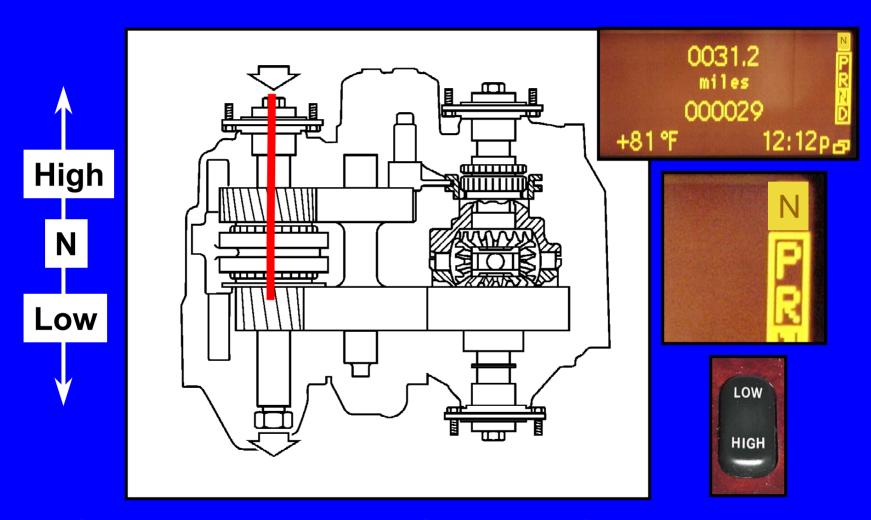
Neutral

Input shaft bearings can be damaged if engine runs for extended period of time with transmission not in park. (no oil reaches bearings)
