# **REFLECTIONS ON RUSSIAN ACCIDENT ON AUGUST 17<sup>th</sup> 2009**

**6,400-MW SAYANO-  
SHUSHENSKAYA  
HYDROELECTRIC POWER PLANT**

By Eugenio Kolesnikov – Miami October 12 2009; revised on October 20.

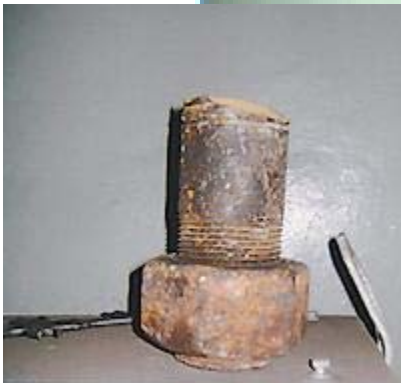
High vibration contributed to the bolts fatigue, their functional capacity was lost, the turbine cover was opened.

# Turbine Cover Bolts Failed on Unit 2

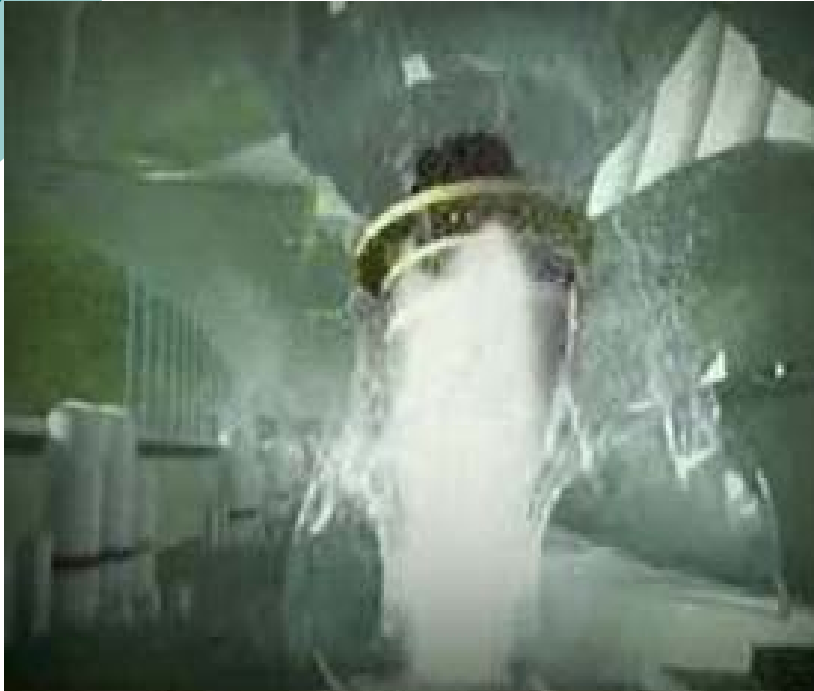
# Flooding of the Powerhouse Started

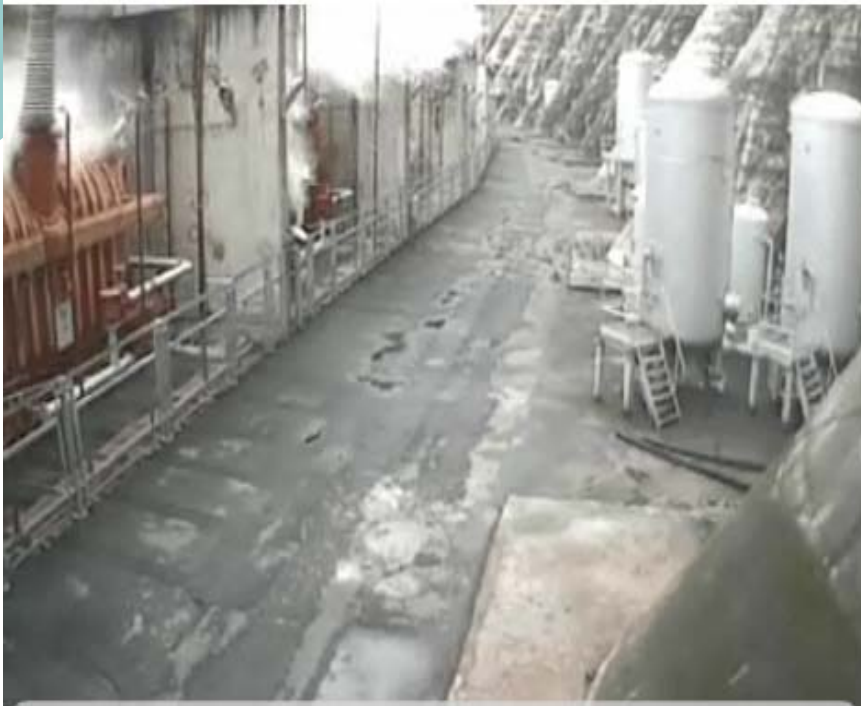
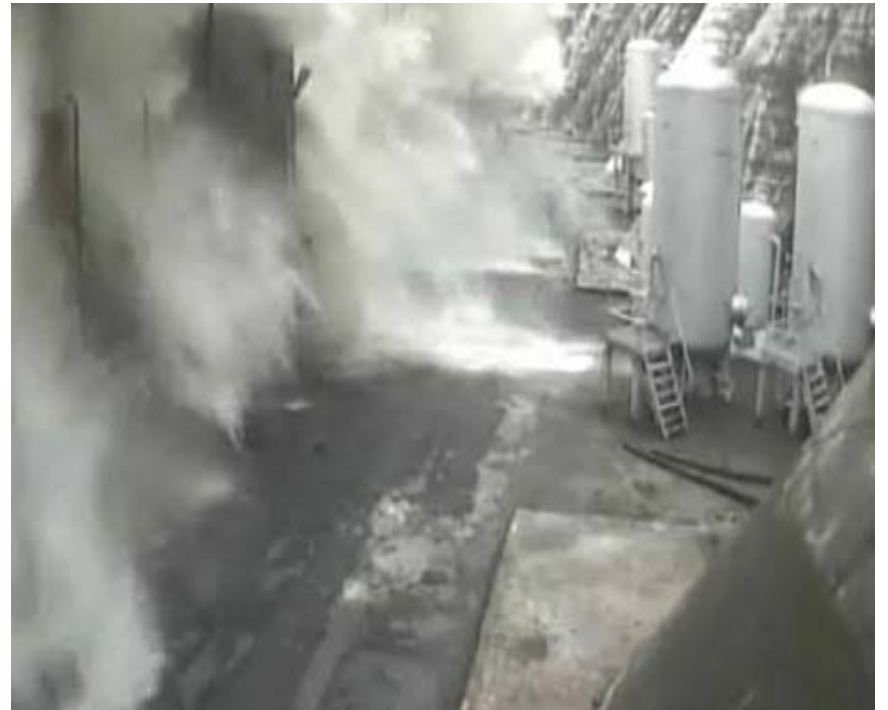
# Flooding of Transformers

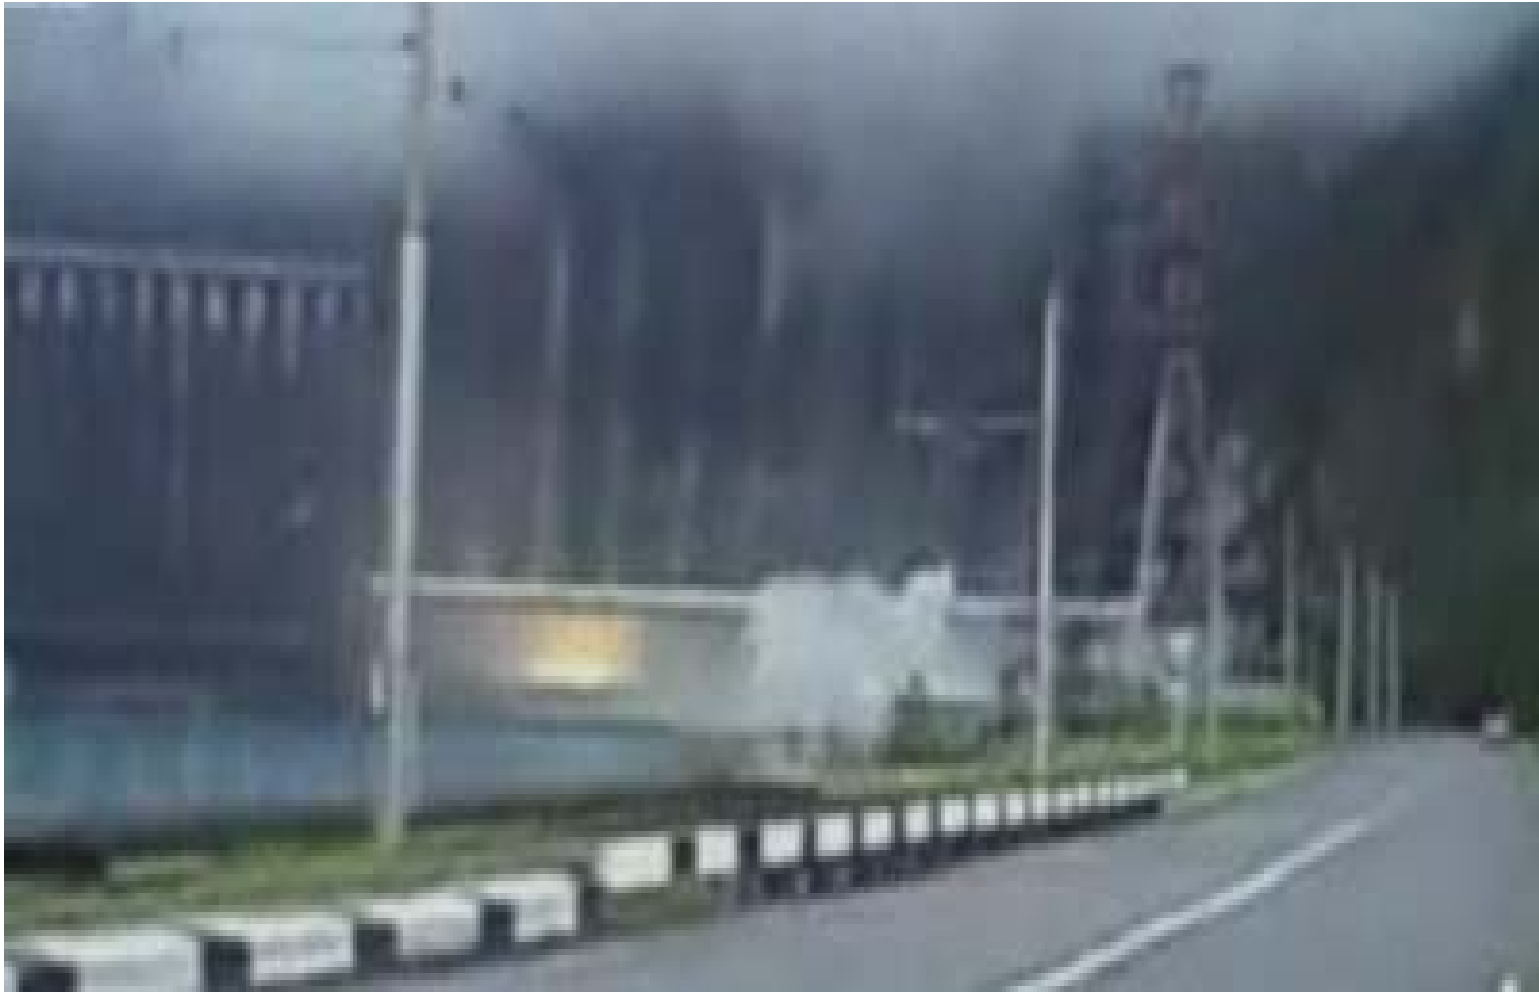
## Section of the Powerhouse has been Washed Away

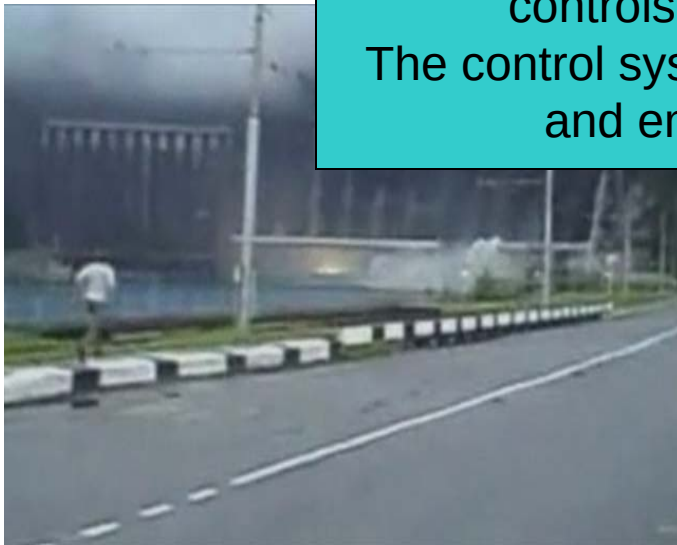
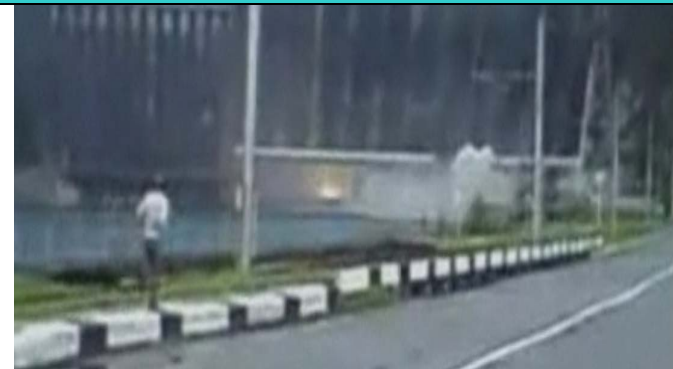
Sudden full flooding of the powerhouse disabled controls and protections of the units;  
The control systems stopped operating (no normal and emergency electricity supply)

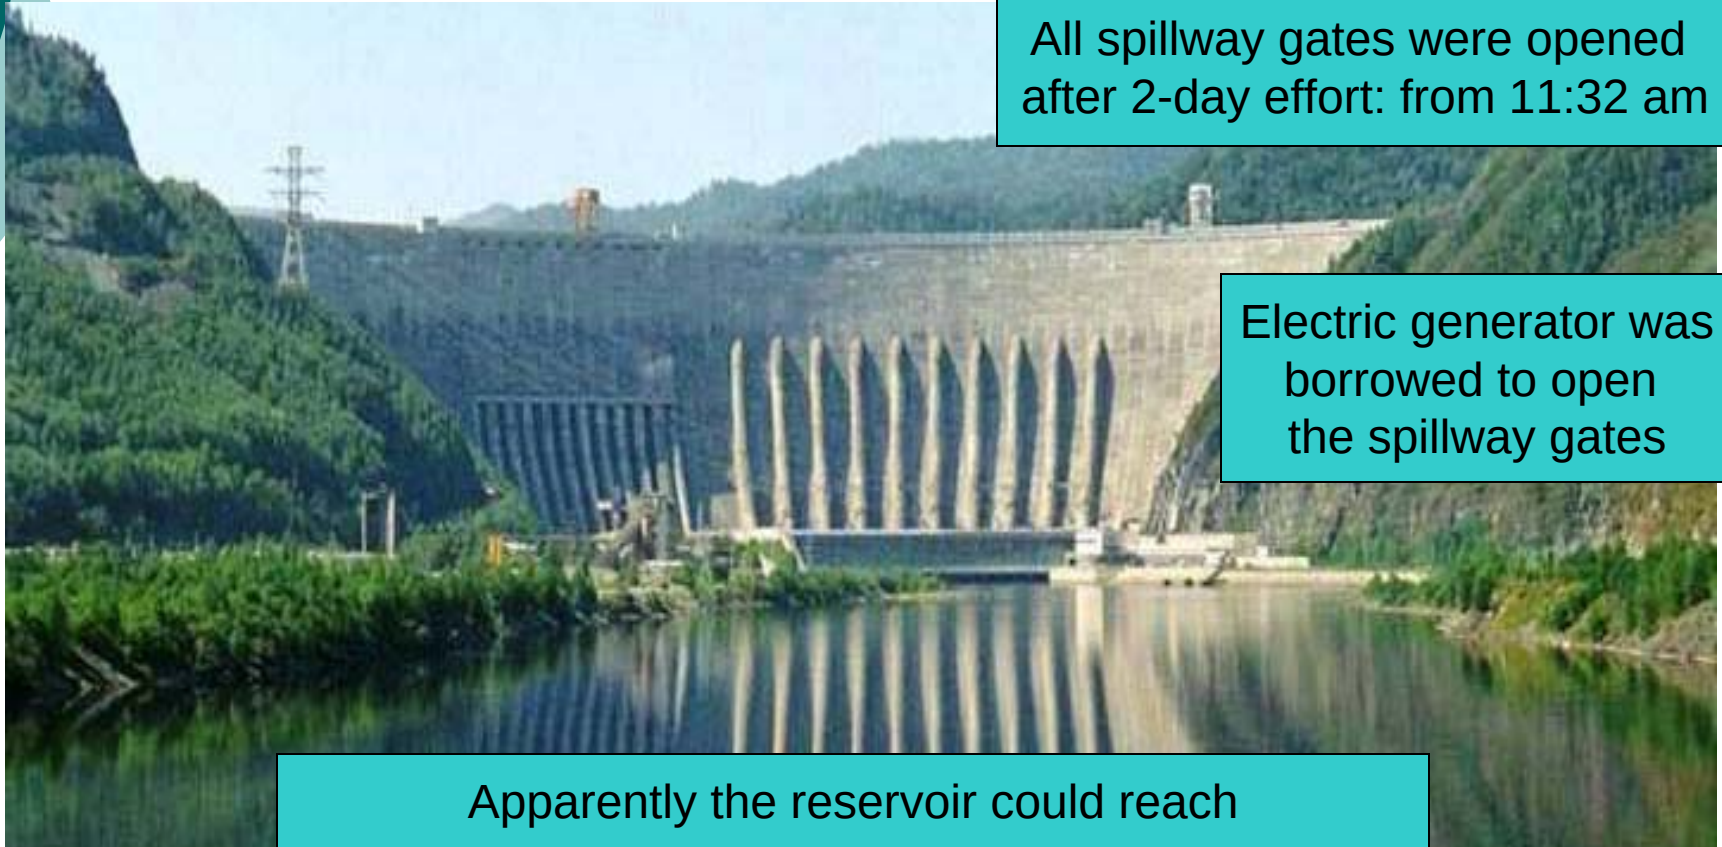
# Overtopping Exposure in 2 days

All spillway gates were opened  
after 2-day effort: from 11:32 am

Electric generator was  
borrowed to open  
the spillway gates

Apparently the reservoir could reach  
overtopping exposure in 2 days after the accident,  
if the spillway would not be opened completely

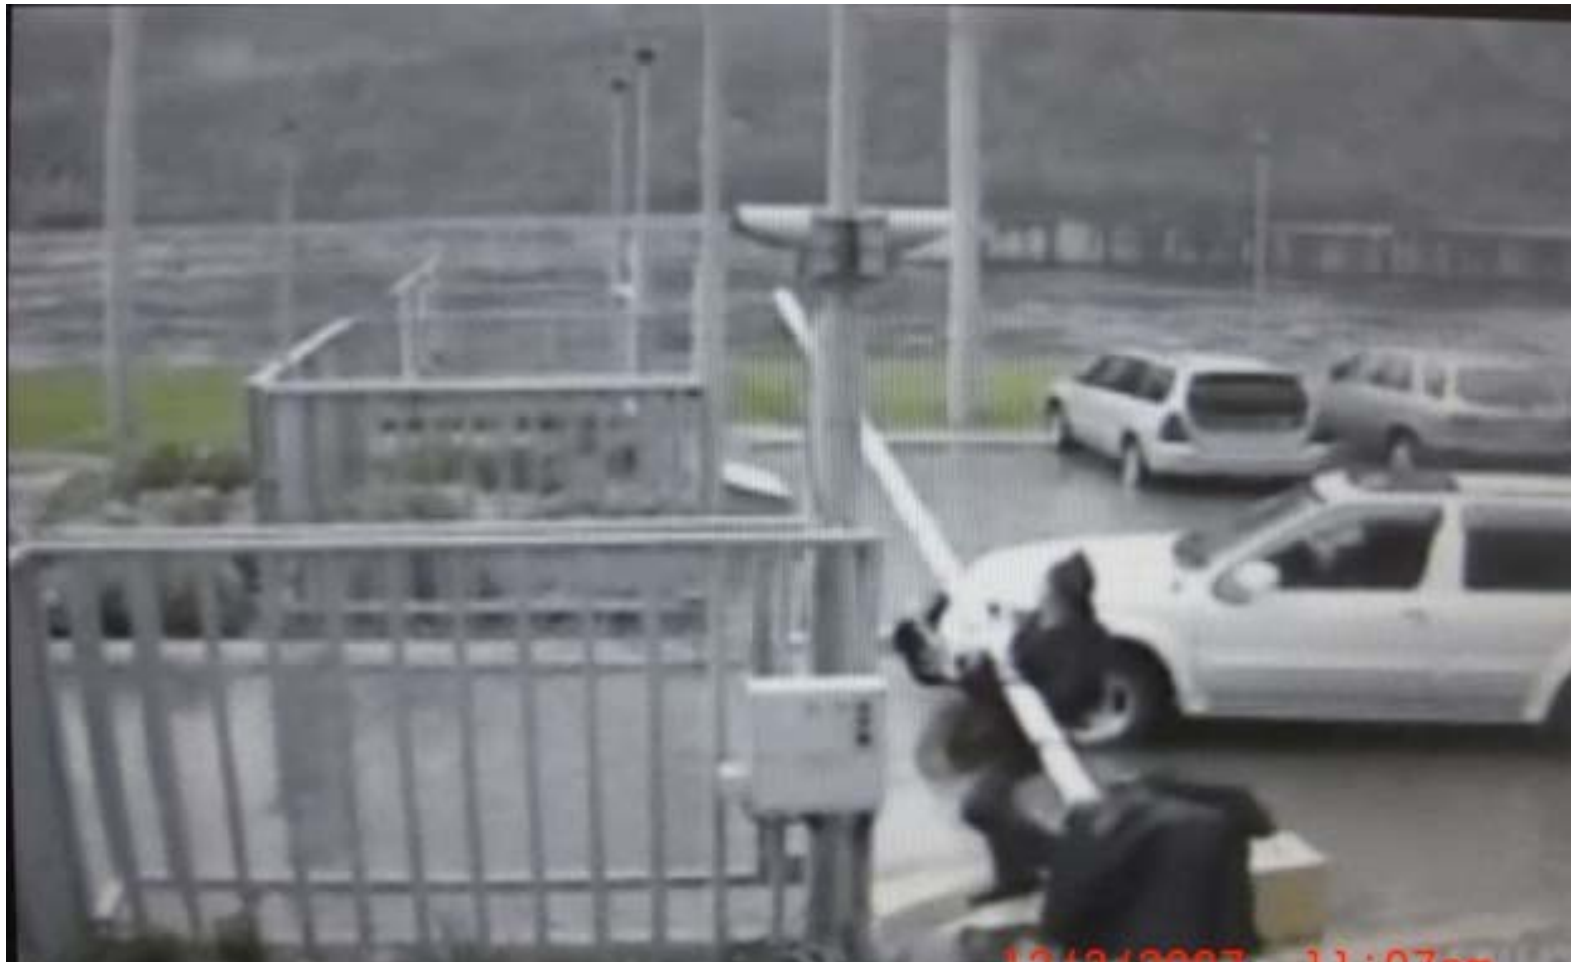
## Emergency Electricity Supply Does Not Function – Manual Attempt To Open The Gate

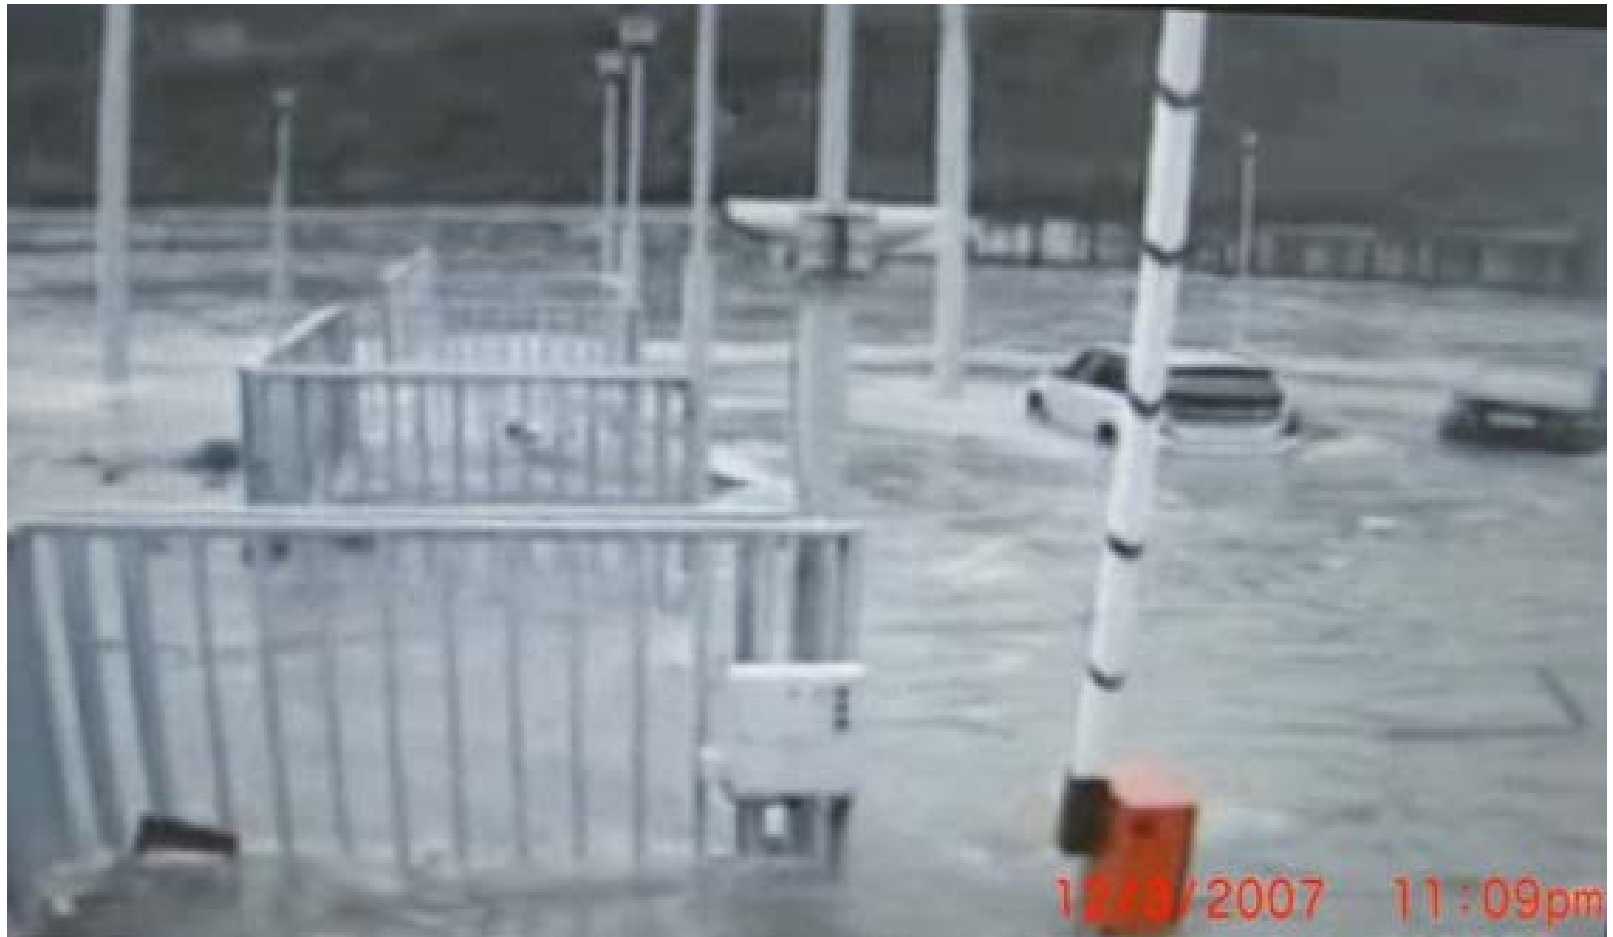
## The Gate Area Several Minutes Later

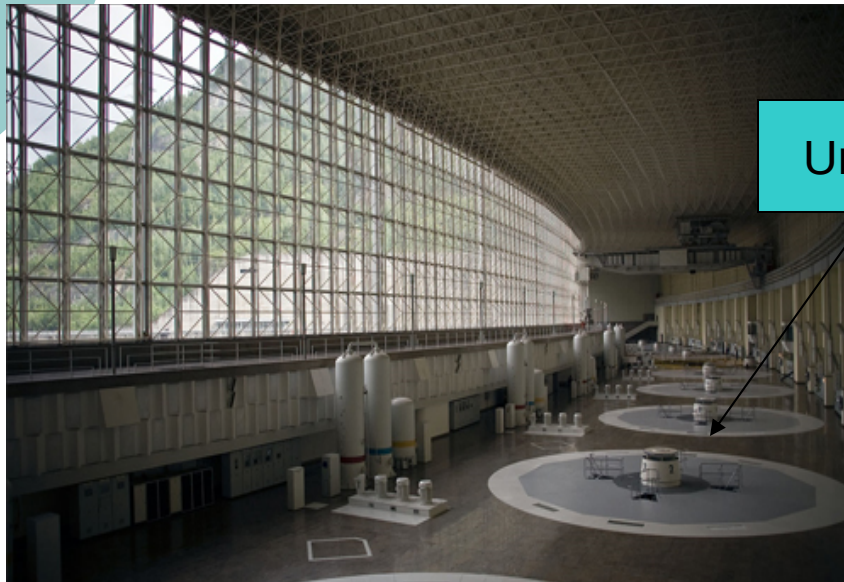
Unit # 1

Total loss of equipment  
inside the powerhouse

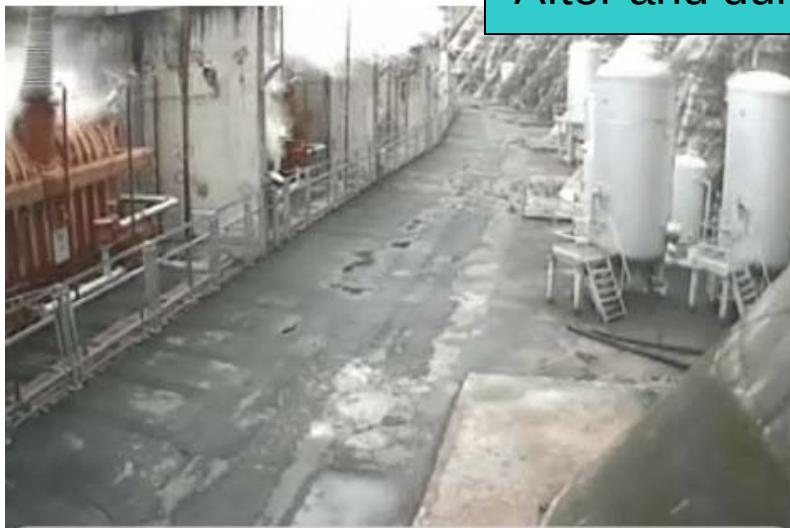
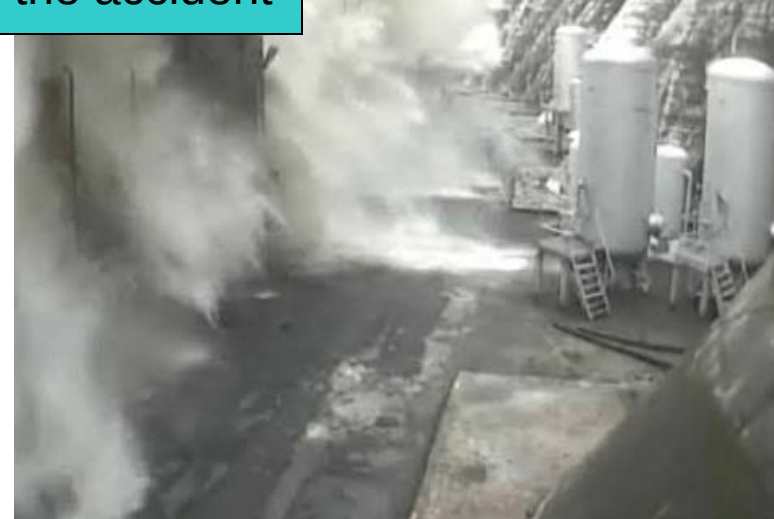
# Damaged Transformers

After and during the accident

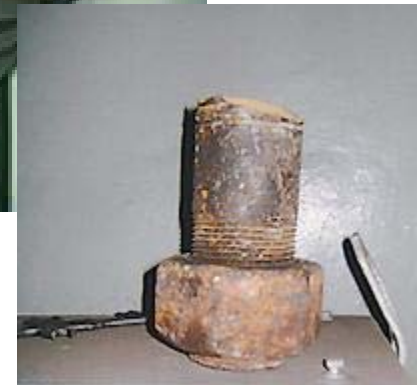
# At Least 6 Nuts Were Not Installed, Total 80 Bolts X 80-mm Diameter

OEM did not specify  
requirements for the bolts maintenance  
and inspections: result-badly worn bolts

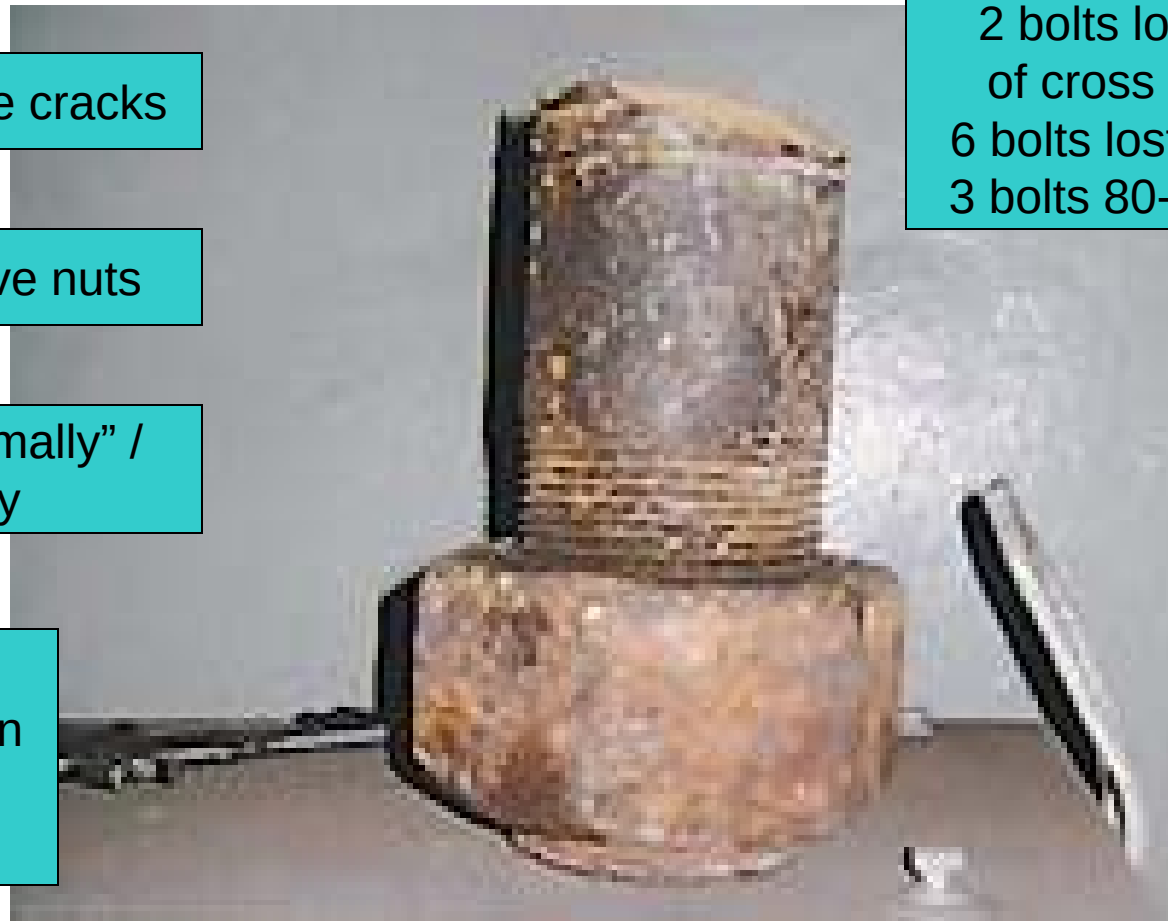
# 47 Bolts Of 49 Laboratory Tested Were Defective (All From Unit 2)

41 bolts had fatigue cracks

49 bolts lost 65%  
of their cross section  
because of the  
fatigue cracks

2 bolts lost 96%  
of cross section  
6 bolts lost 90-95%  
3 bolts 80-85% etc.

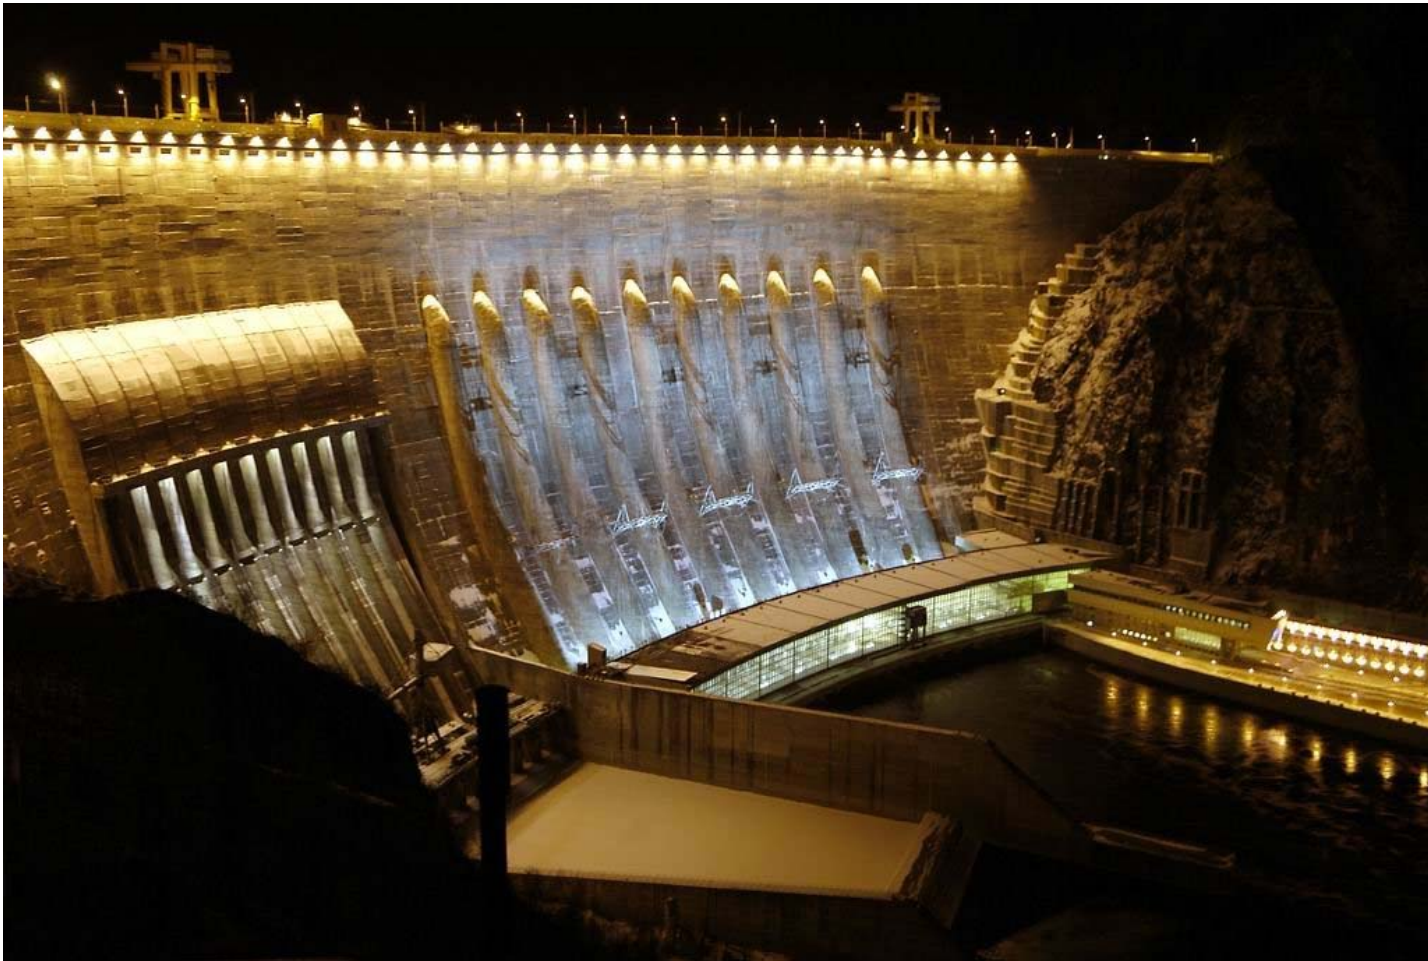
# **The Plant Had Been Flooded Twice In The Past : in 1979 and 1985**
